I15 (i8 Roadster)

A cracking noise can be heard from the roof area while driving over rough roads. The noise can only be heard when the top is fully closed.

Interference between the convertible top hinge and adjustment stop screw.

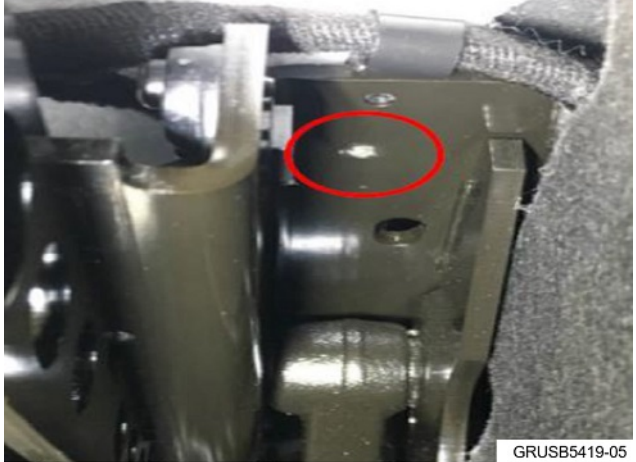
<p>GRUSB5419-04</p>	<p>1. Completely open the convertible top to gain access to the main convertible top hinges (circled) on both sides of the vehicle.</p>
