**SUNROOF REVERSES WHEN CLOSING**

This Service Information Bulletin (Revision 5) replaces SI B54 08 19 **dated November 2020**.

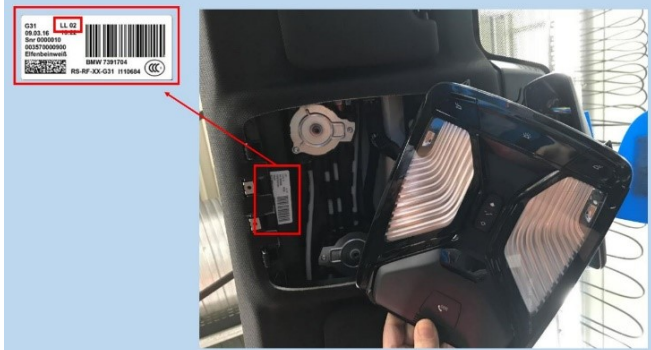
4. With the FZD Removed, inspect the “LL” number as shown to the left.

Is the LL number less than 25 or exactly 45?

Yes: Continue to step 5.

No: Continue to step 6.

5. Replace the wind deflector following repair instructions **REP 54 13 090 “Removing and installing/replacing wind deflector”**.
