RUBBER BUMPER PAD PULLS OFF OF CONVERTIBLE TOP LATCH

E-Series	Model Description	Production Date
G14	8 Series Convertible	Produced until January, 2020
G29	Z4 Roadster	Produced until January, 2020

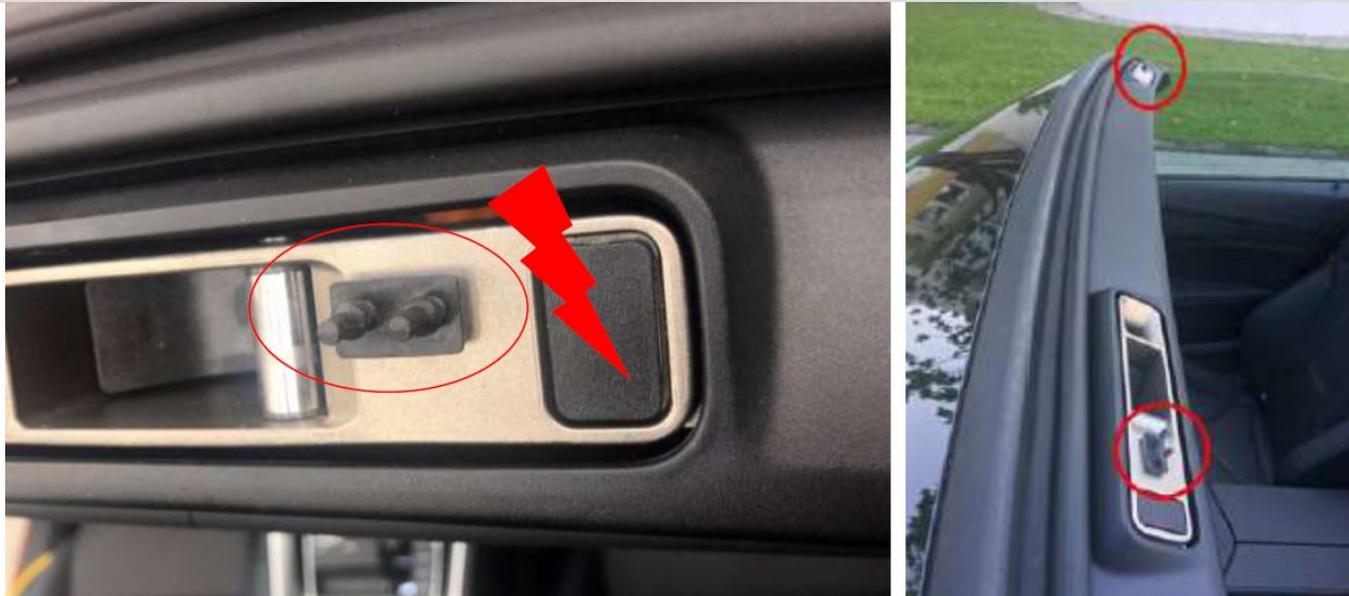
Rubber bumper pads (circled) are normally attached to the latch on the convertible top. Under certain circumstances, one or both pads stick to the corresponding latch plate above the windshield, pulling away from the latch. This can also cause a check control message 270 stating that the soft top is not locked.

The mating surface of the bumper pad is too smooth, so that it can possibly stick to the latch plate above the windscreen panel.

Scuff the mating surfaces of the bumper pads and reinstall. No adhesive is necessary.
