SERVICE ACTION: PROGRAM OR REPLACE DUAL STORAGE SYSTEM BATTERY

This Service Information Bulletin (Revision 2) replaces SI B61 03 19 **dated April 2019**.

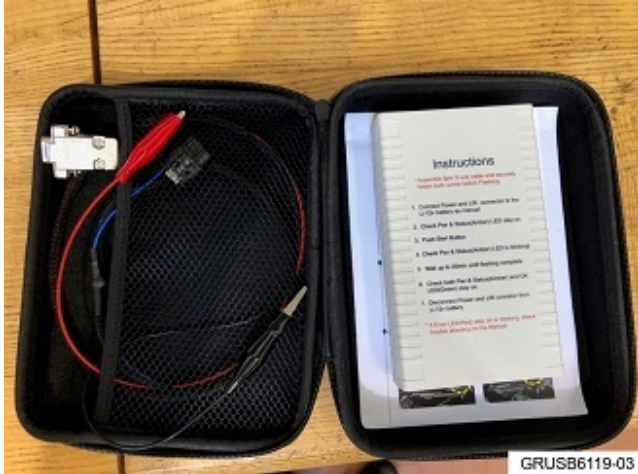
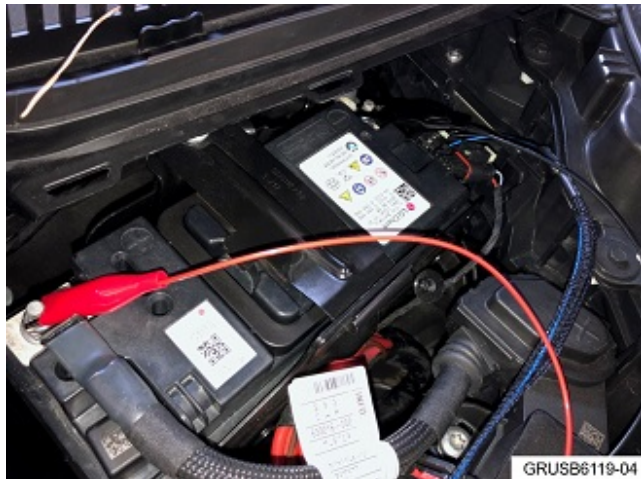
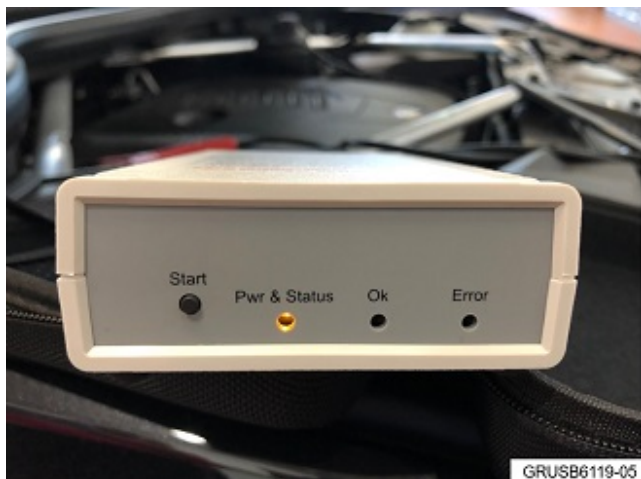
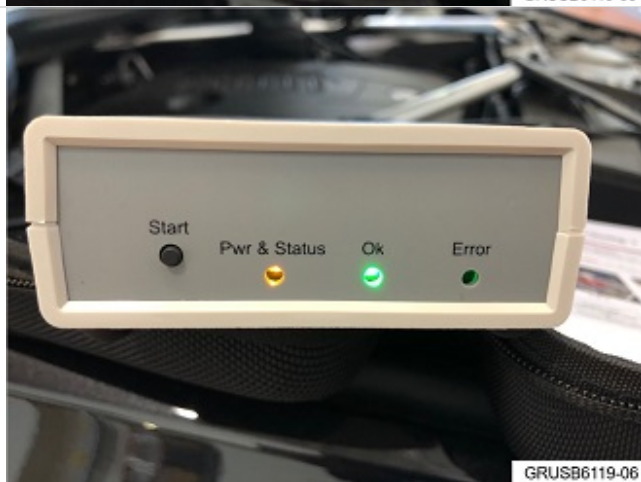
A software error intermittently causes a continuous resetting of the microcontroller in the power management system. This causes the red Check Control Message (CCM) "Replace Battery" to be illuminated.

Software error in Dual Storage System Battery

5. Remove the 4-pin connector from the battery and connect the 4-pin adapter from the tool.

6. Connect the power and ground from the tool directly to the battery terminals.

7. Place the flashing tool away from any engine heat.

8. Once connected, the flashing tool amber LED (Pwr & Status) will be lit up.

9. Press the start button and the amber LED will flash indicating the DSS battery is being programmed.
