This Service Information bulletin supersedes SI B61 04 05 dated July 2005.

UPDATE! E90	UPDATE! Equipped with option 522 (Xenon lights)
--------------------	--

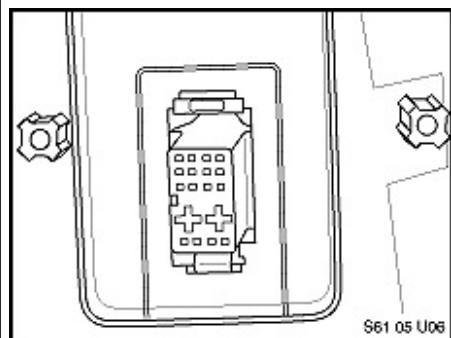
Left and/or right headlight housing cover is not properly fitted allowing water ingress into the Stepper Motor Controller (SMC) connector.

2. **UPDATE!** Inspect the connector at each headlight (X13420 – Left and X13421 – Right) assembly for corrosion and replace as necessary.

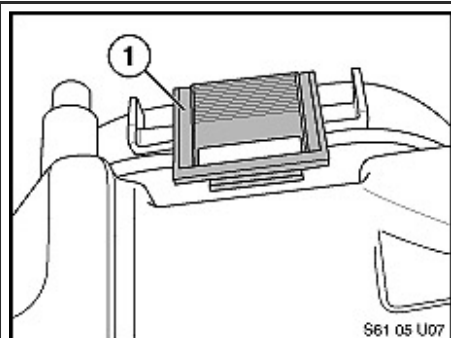
Left and/or right headlight housing cover is not properly fitted allowing water ingress into the Stepper Motor Controller (SMC) connector.

3. **UPDATE!** Make sure the headlight access covers (1) are installed correctly.
4. **UPDATE!** Clear the faults and test the headlights for proper function.
