## MODEL

G30 (5 series Sedan)			
Produced through November 15, 2016

Front windshield washers spray poorly or not at all.

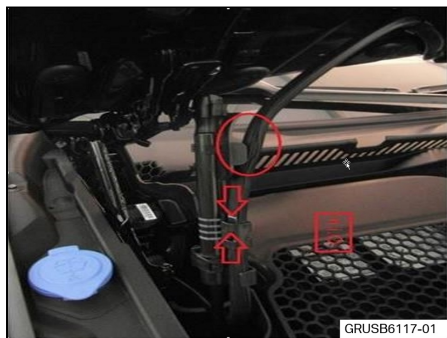
Partially or completely pinched supply tube caused by misplaced tube holder on hood hinge.

Reposition and secure tube holder on the gas pressure spring.
