## Washer Fluid Reservoir Rattles While Driving on Rough Roads

This Service Information Bulletin (Revision 4) replaces SI B61 06 15 **dated April 2021**.

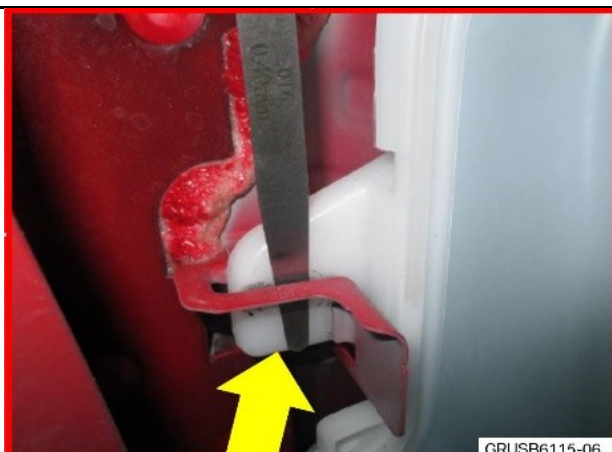
The windshield washer reservoir upper plastic locating guide tab has too much lateral play.

- Note: The close-up picture shows a gap (0.40 mm) that exists between the plastic reservoir guide and the metal securing bracket.**
6. With the reservoir removed, clean the upper guide tab with a clean cloth.
  7. Prepare a piece of felt tape (80 x 60 x 1 mm) and apply it to the guide tab in the area shown.
  8. The felt tape will eliminate the rattling noises coming from the metal bracket which can transmit into the glove compartment area. Reinstall the removed parts in the reverse order of their removal.

Apply a piece of self-adhesive felt tape to the upper plastic locating guide of the washer fluid reservoir.
