F39 (X2 Sports Activity Coupe)	F48 (X1 Sports Activity Vehicle)
--------------------------------	----------------------------------

Situation

During vehicle production, there is the possibility that the cavity preservation wax leaked from the body and dripped onto the Body Domain Controller (BDC) and its wiring harness connector. The BDC is located inside the vehicle, in the front passenger footwell.

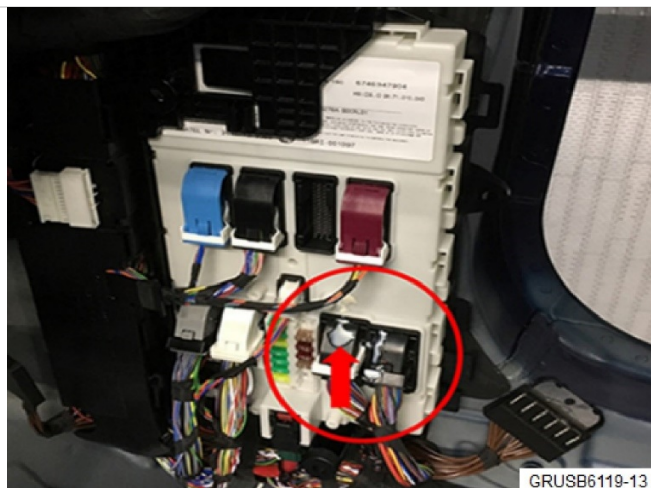
1. Access the BDC as described in Repair Instructions REP 61 35 278 "Remove/install Body Domain Controller (BDC)".

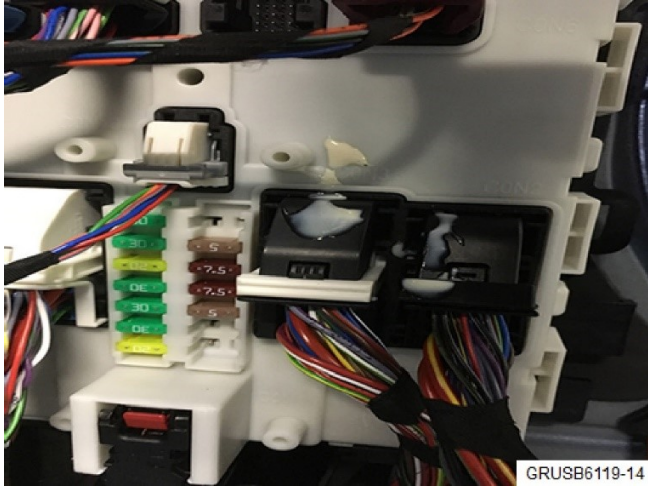
GRUSB6119-14

1. Perform visual inspection of BDC and connectors looking for cavity wax.

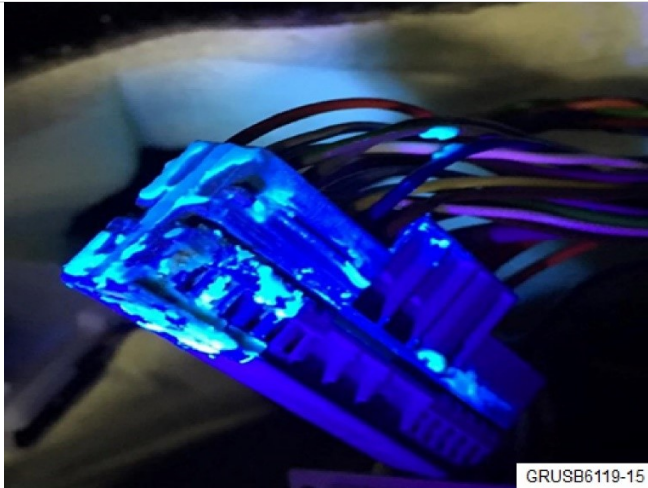
GRUSB6119-15

1. Check connectors A258*3B and A258*2B with an ultraviolet lamp for contamination.

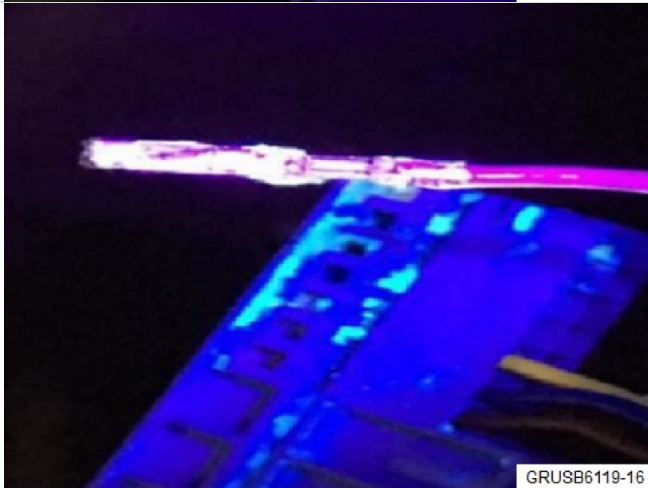
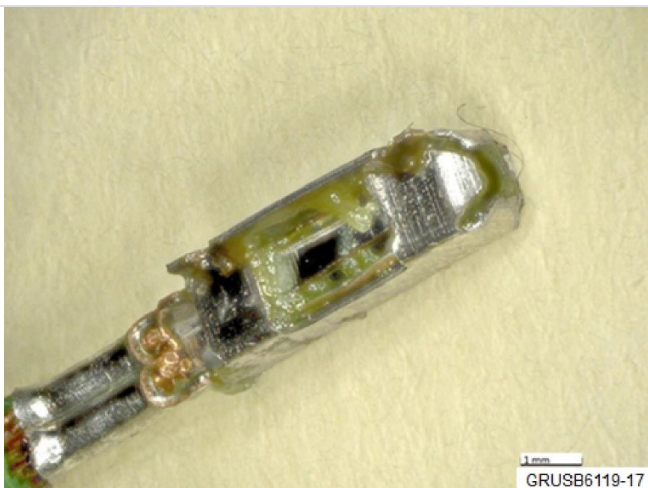
1. If the connector housing, socket housing and pins are contaminated per the two photos at left, then they will need to be replaced.

Caution:
Make sure that the new pins are not touched with hands contaminated by cavity preservation wax, as otherwise contact resistances can be expected again.

Hence the hands have to be cleaned before crimping the new pins.
