Groning, scraping, or squeaking noise coming from the steering wheel area in the interior of the vehicle, when turning the steering wheel.

Defect Code:	6112553900	Control unit of steering column switch cluster incl. coil spring cassette, interference noises
---------------------	-------------------	---

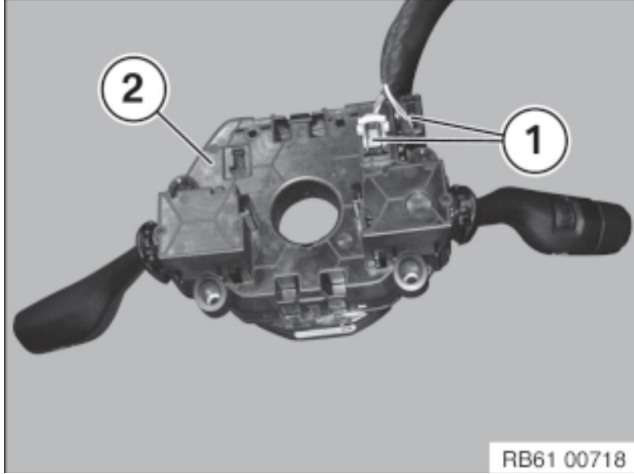
YES: Carry out further diagnosis in the steering column, in this case the (SZL) steering column switch cluster / coil spring cassette is not the cause of the noise.

remove the steering column switch cluster (SZL) (2) as per **REP 61 31 008** Removing and installing steering column switch cluster

Note: Put the wheels in the straight-ahead position.

Re-install the steering wheel without the SZL according to repair instructions and turn the steering wheel from one limit position to the other while stationary.

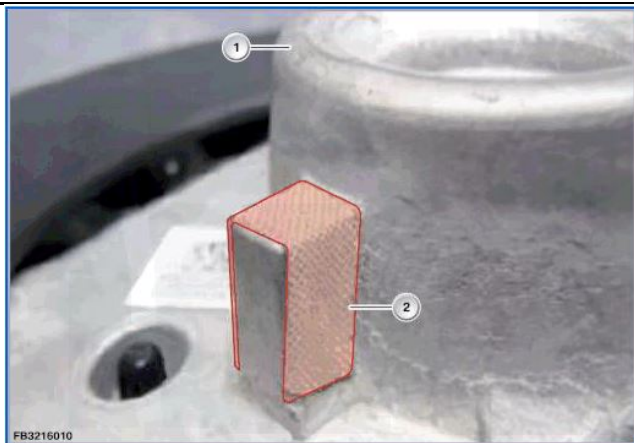
Check whether a sliding tape is bonded on the drive flange on the steering wheel.

If adhesive tape (white or black) is affixed on the drive flange on the steering wheel, remove it and clean the bonding surfaces (2) with safety solvent cleaner (P/N 83 19 2 451 316).

Then grease the coil spring cassette and steering wheel.
