SERVICE ACTION: CHECKING THE SIGNAL WIRE AT POWER DISTRIBUTION BOX

G05 (X5 Sports Activity Vehicle)	G07 (X7 SAV)	G12 (7 Series Sedan)	G14 (8 Series Convertible)
G20 (3 Series Sedan)	G29 (Z4 Roadster)

This Service Action involves the above-referenced models produced from July, 2018 to April, 2019.

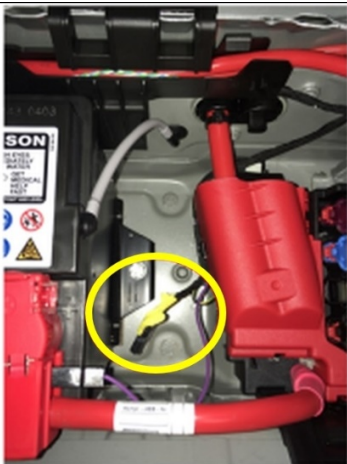
<p>GRUSB6119-17</p>	<p><b>For G12, G14, G20 and G29:</b> Check the signal wire in the luggage compartment under the luggage compartment cover for correct installation.</p> <ul style="list-style-type: none"> <li>• If the signal wire is not plugged in, assemble correctly.</li> </ul> <p><b>For G05 and G07:</b></p> <ol style="list-style-type: none"> <li>1. Disassemble the storage tray in the luggage compartment under the luggage compartment cover.</li> <li>2. Check the signal wire for correct installation. <ul style="list-style-type: none"> <li>• If the signal wire is not plugged in, assemble correctly.</li> </ul> </li> </ol> <p>Connector (circled) shown not plugged in.</p>
	<p>Connector (circled) plugged into the Battery Safety Terminal.</p>

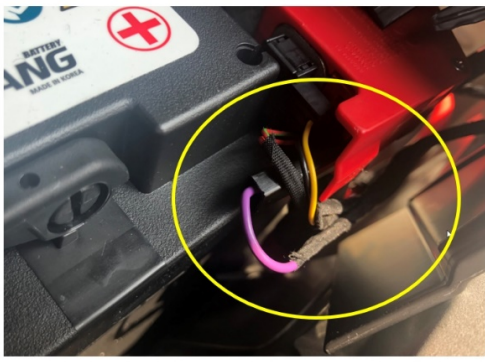
GRUSB6119-18

<p>Note: Photo shows a G20. Other models may be slightly different.</p>

Check the signal wire on the power distribution box in the luggage compartment for correct installation.
