**DELIVERY STOP: REPLACE "SMART OPENER" CONTROL UNIT**

This Service Information Bulletin (Revision 2) replaces SI B61 13 22 **dated June 2022**.

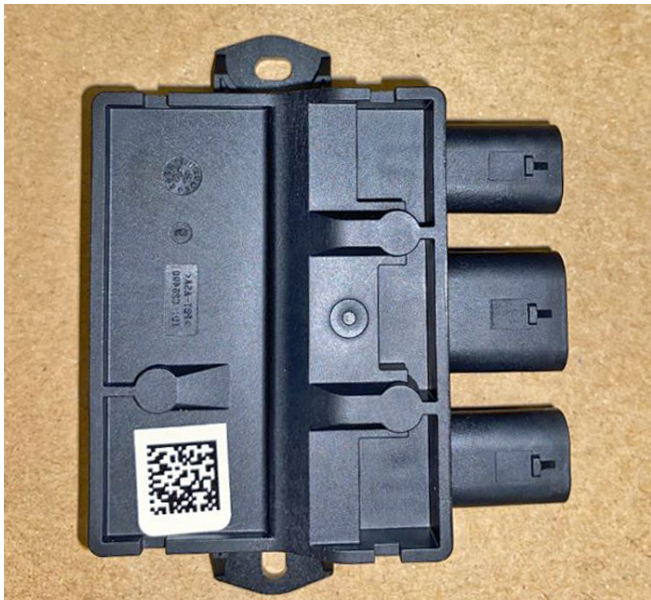
1. Access the smart opener module per AIR repair instructions **61 35 240 "Removing and installing the control unit for contactless trunk opening"**.

2. Remove and discard the "non-functional" smart opener control unit which acted as a circuit "jumper".

Note that the jumper unit closely resembles the replacement part- Do not mix them up!

Discard the factory-installed jumper unit.

3. Install the functional smart opener control unit P/N 61 35 5A3F3E8 or P/N 61 35 5A562D6. Both P/N are interchangeable.
