## DELIVERY STOP: TRUNK LOCK SWITCH WIRING HARNESS

This Service Information Bulletin (Revision 1) replaces SI B61 15 20 **dated June 2020**.

E-Series	Model Description	Production Date
G20	3 Series Sedan	March 25, 2020 – March 26, 2020

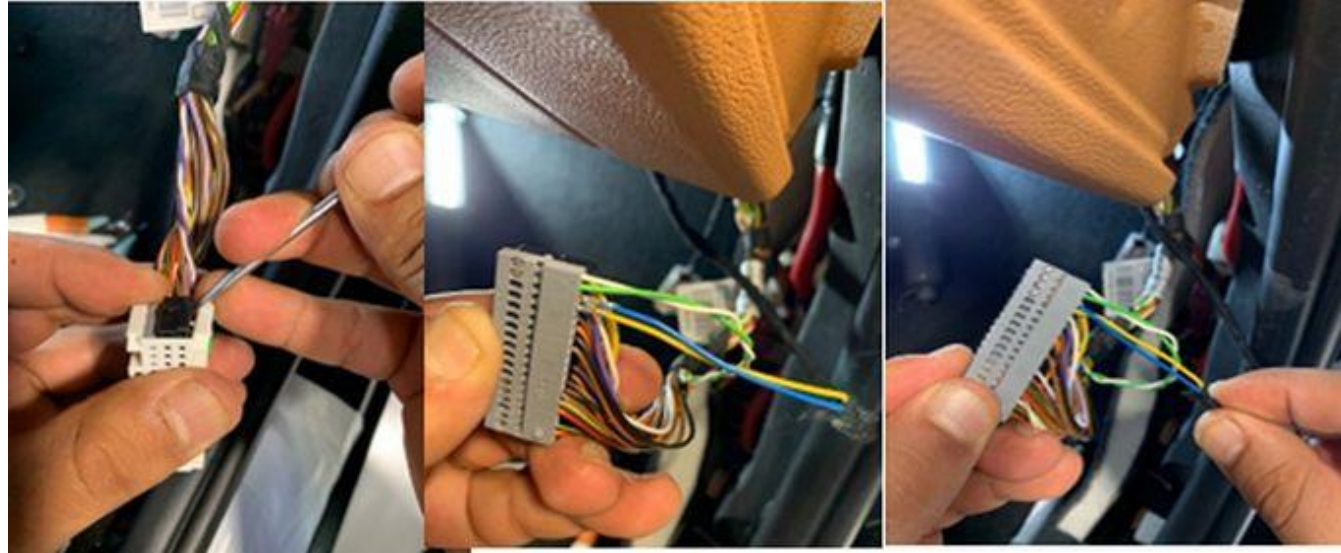
The wire from the Body Domain Controller (BDC) to the wiring harness connector leading to the hotel position switch is missing.

1. Open the connector A258\*7B with tool 94018 or 89090.
2. Insert one end of the previously marked wire into chamber 52 and one end of the other wire (not marked) into chamber 51. Close the connector.
