RECALL 20V-601: HIGH-VOLTAGE BATTERY RECALL

This Service Information Bulletin (Revision 10) replaces SI B61 23 20 **dated April 2021**.

BMW AG is conducting a Voluntary Safety Recall (effective September 24, 2020) on certain Model Year 2020-2021 BMW Plug-In Hybrid-Electric (PHEV) vehicles that were produced between February 22, 2020 and September 17, 2020.

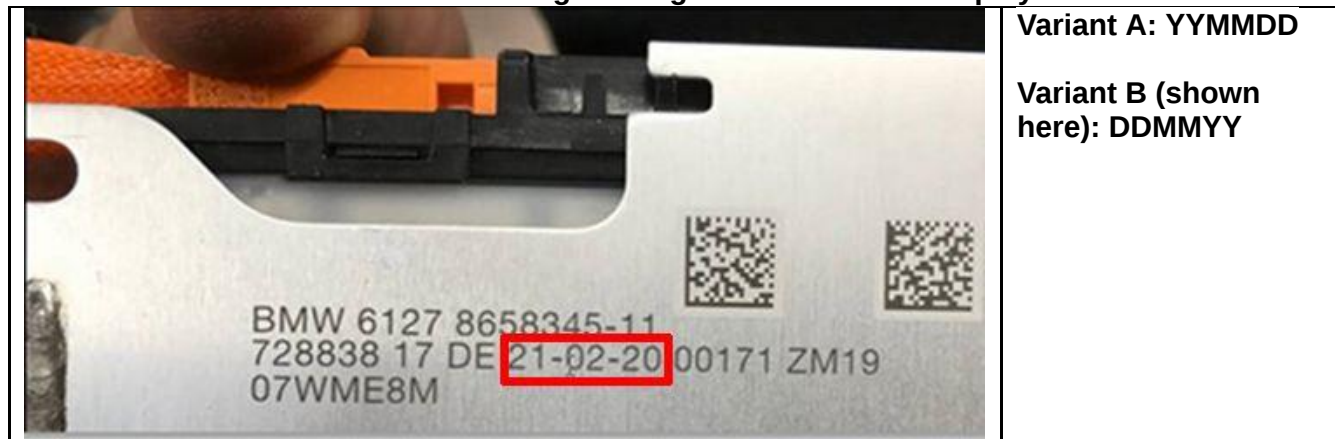
Note:
The date in the serial number of the High-voltage module can be displayed in two different formats:

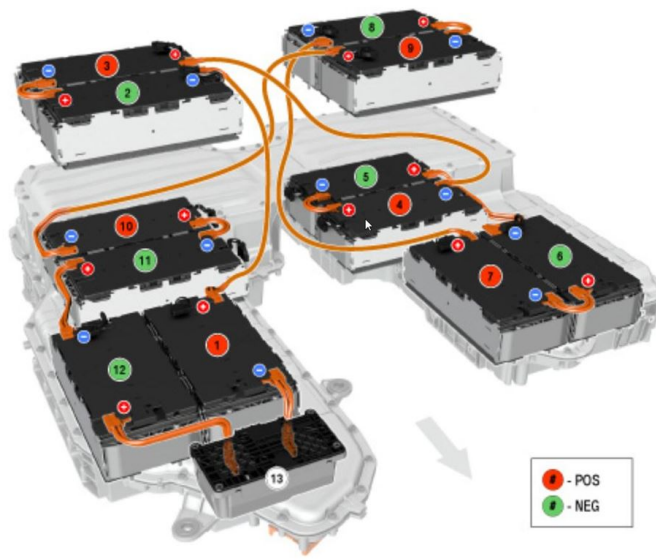
SP44 HV Battery (G05) modules-

G05 modules (SP44 HV battery) are:

NEG (01) or POS (02)

- Module 12 is **NEG (01)**
- Module 1 is **POS (02)**
- Module 11 is **NEG (01)**
- Module 10 is **POS (02)**
- Module 2 is **NEG (01)**
- Module 3 is **POS (02)**
- Module 8 is **NEG (01)**
- Module 9 is **POS (02)**
- Module 5 is **NEG (01)**
- Module 4 is **POS (02)**
- Module 6 is **NEG (01)**
- Module 7 is **POS (02)**

Modules are designed as Positive and Negative modules (with different orientation and part numbers). When replacing modules, verify in EPC the correct part (POS/NEG) and reinstall according to their original position. See below.

Use EPC diagram to verify the correct module part number (01/02) for NEG or POS modules.

Use the illustration on the right to match the part# with the correct module installation location.

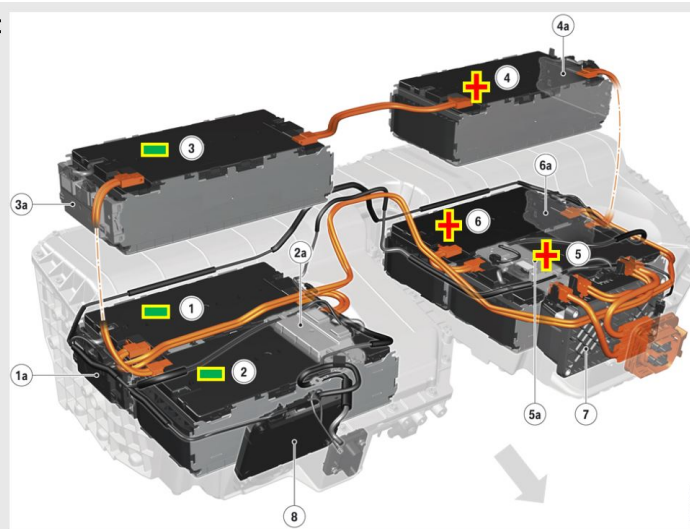
SP41 HV Battery (G01/G20/G20/G12) modules-

G01/G20/G30/G12 LCI modules (SP41 battery) are:

NEG (01) or POS (02)

- Module 1 is **NEG (01)**
- Module 2 is **NEG (01)**
- Module 3 is **NEG (01)**
- Module 4 is **POS (02)**
- Module 5 is **POS (02)**
- Module 6 is **POS (02)**

Use EPC diagram to verify the correct module part number (01/02) for NEG or POS modules.

Use the illustration on the right to match the part# with the correct module installation location.
