INSTRUMENT CLUSTER AND ONBOARD COMPUTER INTERMITTENTLY INOPERATIVE

This Service Information Bulletin (Revision 4) replaces SI B62 01 19 **dated November 2019**.

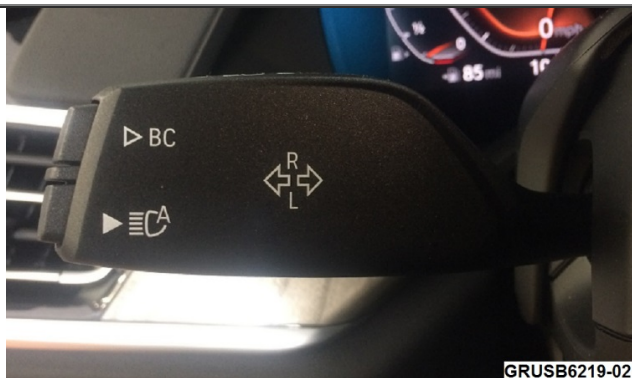
Instrument Cluster (KOMBS18) functions are intermittently inoperative, including:

- On-board Computer (BC) button on turn signal stalk (BC button shown at left)
- Radio displays
- Menu button
- Turn signal displays
- Arrows on multifunction steering wheel
- MFL thumbwheel control (shown at left)

Program the vehicle.

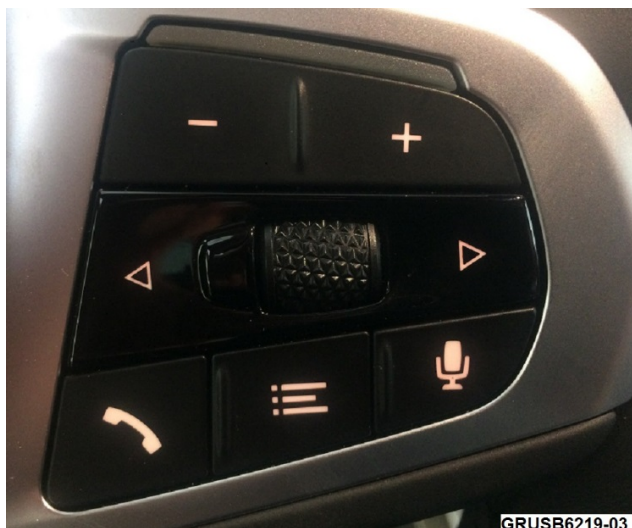
Additionally, the audio source, radio station, or music track cannot be changed using the MFL.
