E-Series	Model Description
G01	X3 Sports Activity Vehicle
G02	X4 Sports Activity Coupe
G12	7 Series Sedan
G30	5 Series Sedan
G32	640i xDrive Gran Turismo

Temporary black screen in the instrument cluster.

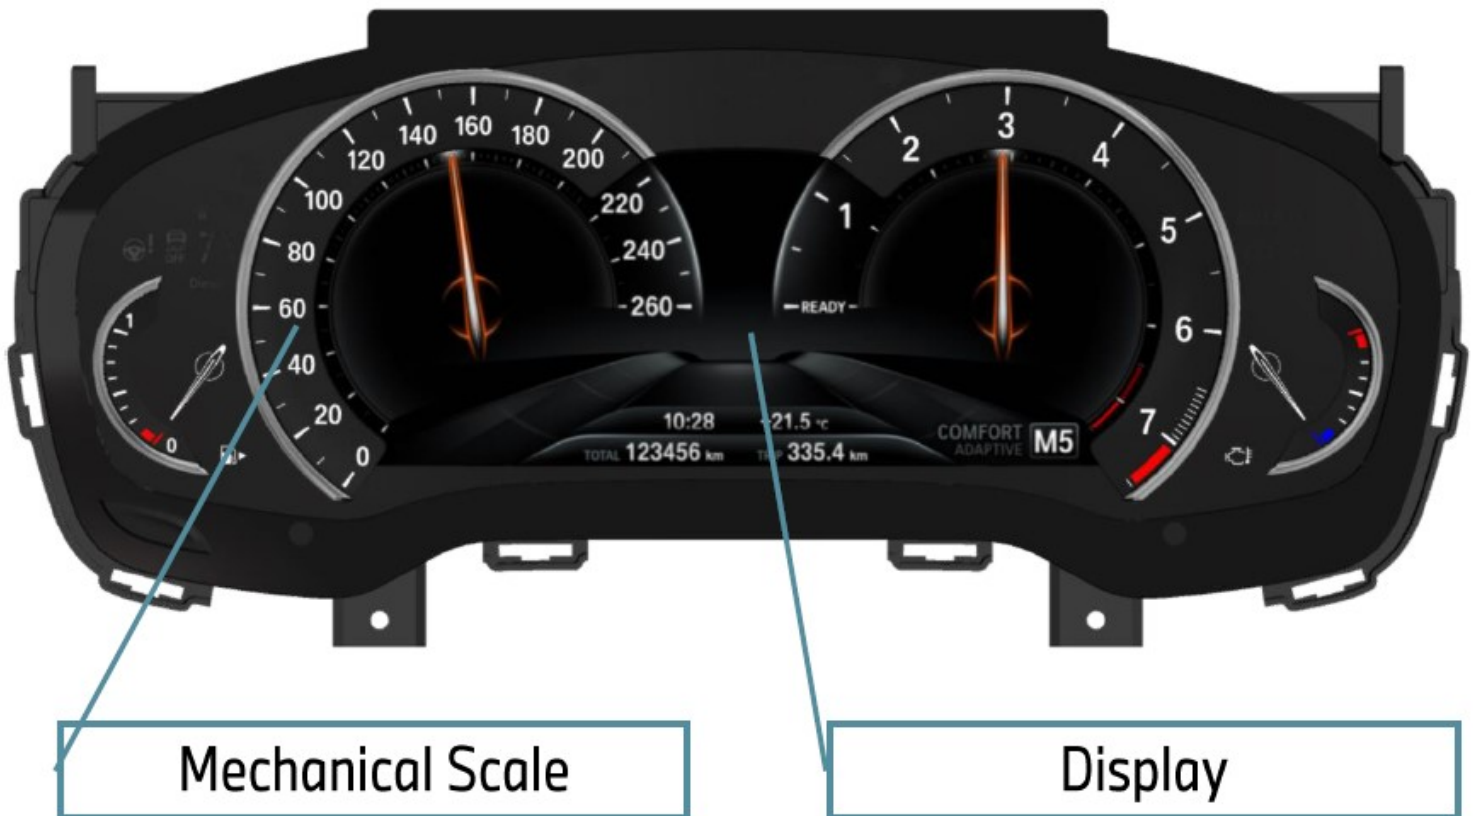
Kombi MID ON

This only affects vehicles with instrument cluster version MID Generation 4 (Kombi MID); reference the image below to identify the correct instrument cluster.
