INSTRUMENT CLUSTER DISPLAY SHAKES-SHIFTS TO THE LEFT

This Service Information Bulletin (Revision 5) replaces SI B62 08 18 **dated December 2020**.

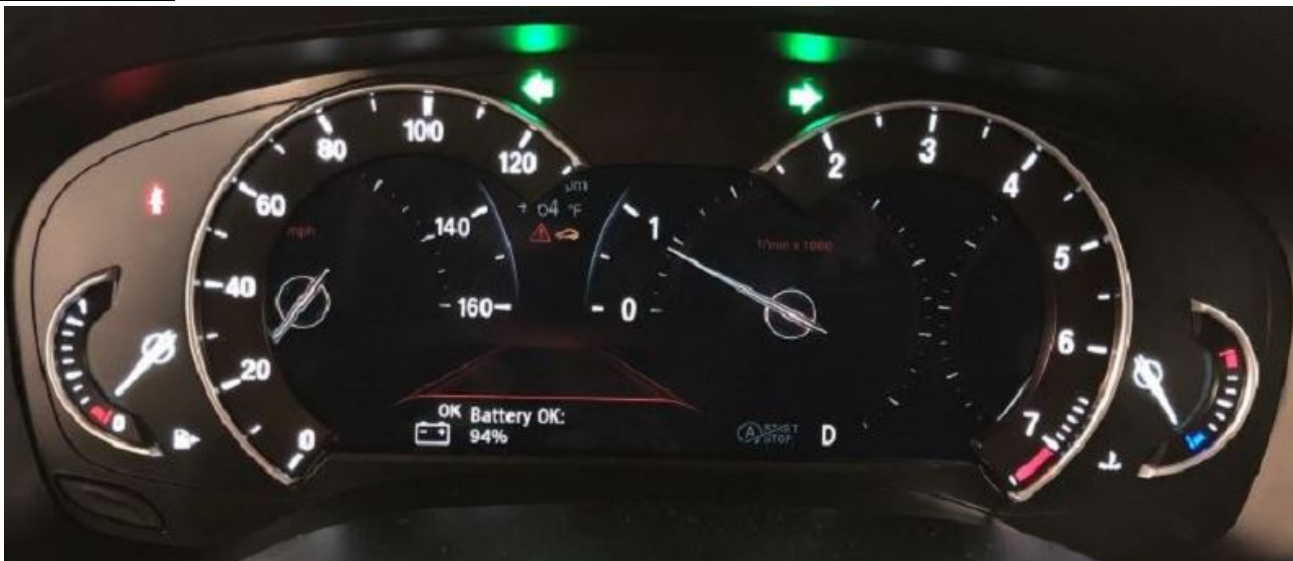
The Instrument cluster

intermittently flickers, shakes and has shifted to the left.

Problem with the contact at the Automotive Pixel Link connection plug on the instrument cluster.

Software error in the Instrument cluster (Kombi)

Replace the instrument cluster (Kombi).

Program vehicle and perform ABL Dashboard: "Display jitters/shifts to the left"
