E-Series	Model Description
G30	5 Series Sedan
F90	M5 Sedan

The trunk-mounted brake light remains lit for several seconds after the brake pedal is released. The length of time will vary depending on ambient temperature and voltage supply.

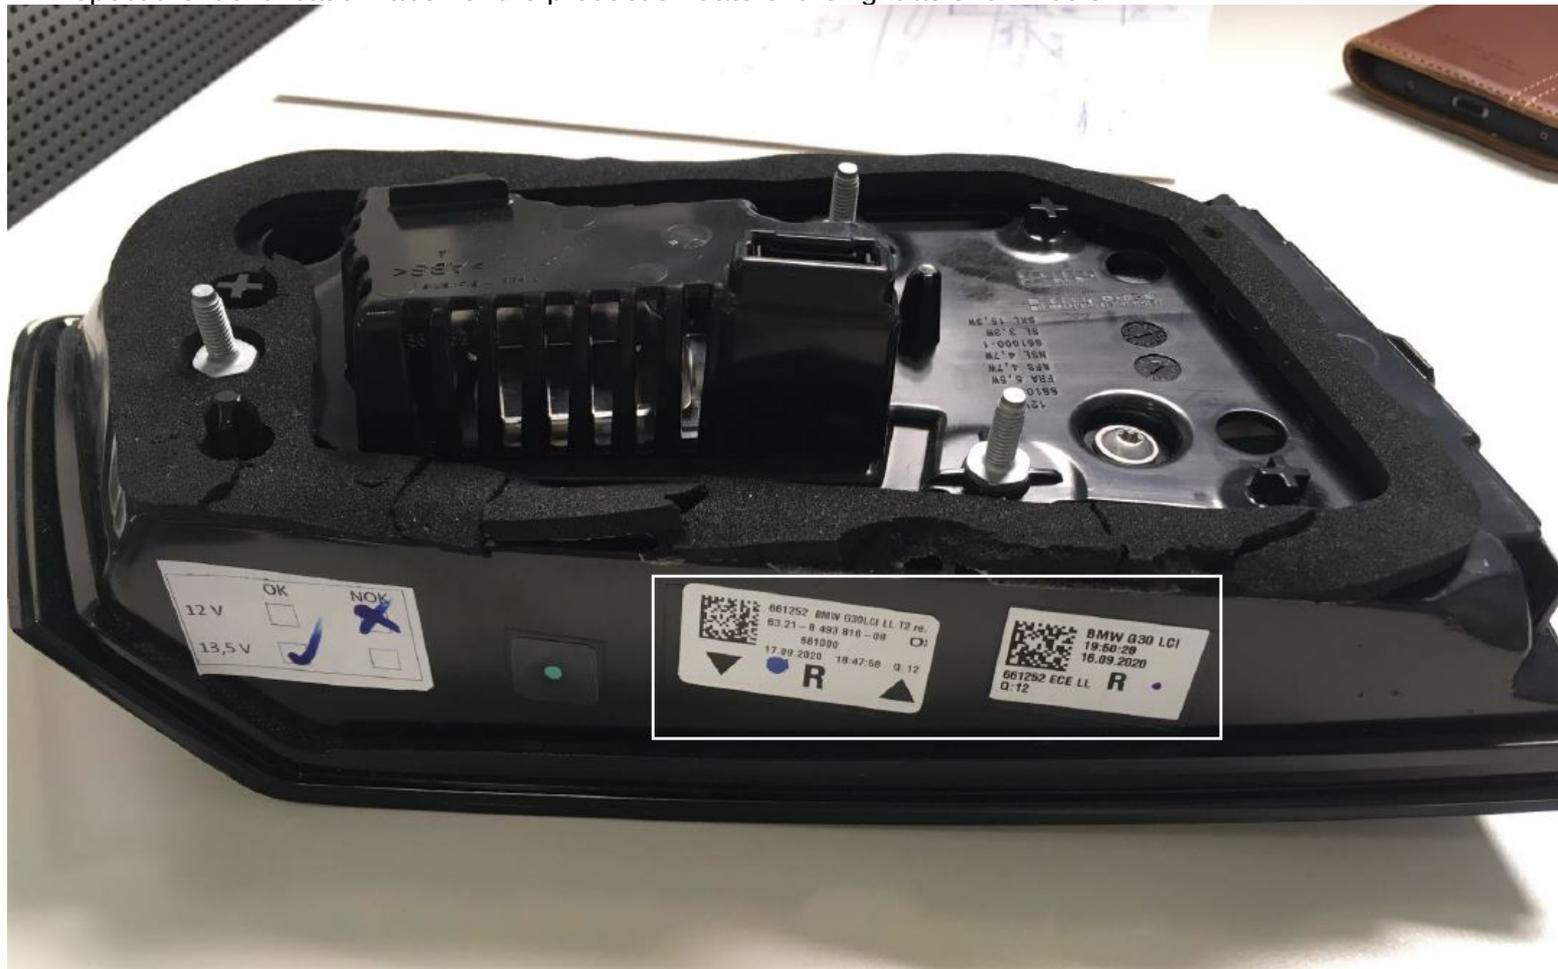
1. Remove the trunk-mounted brake light on the affected side following ISTA repair instructions **REP 63 21 279** "Removing and installing left light of trunk lid".
2. Inspect the identification label for the production date of the light as shown below:

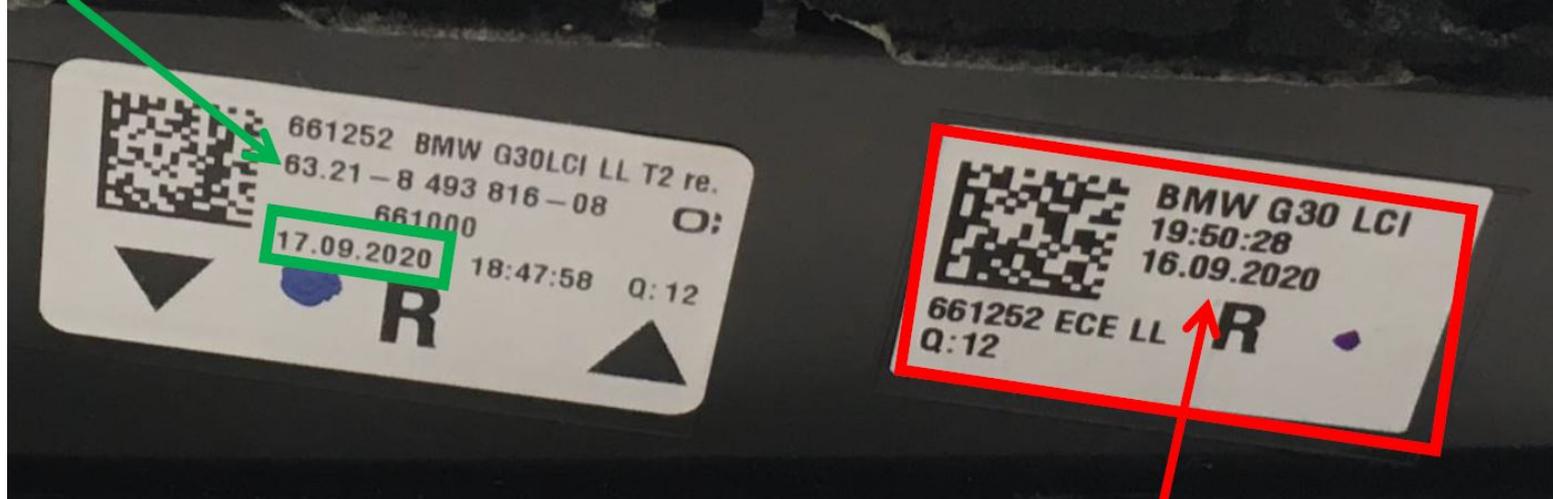
3. The label to be inspected is shown in detail below. There are two labels, each with a date code. The label with applicable date code is shown in green. The label shown in red is not applicable and can be ignored.

4. Is the date code shown above in green produced after September 28, 2020?

Yes: Continue troubleshooting, this bulletin does not apply.

No: Replace the trunk mounted taillight following ISTA repair instructions **REP 63 21 279** "Removing and installing left light of trunk lid".
