## MODEL

| <b>E-Series</b> | <b>Model Description</b> | <b>Production Date</b> | <b>Affected Option Code</b> |
|---|---|---|---|
| G30 | 530e, 530e xDrive Sedan | Up to December 31, 2020 | PHEV Only |

## SITUATION

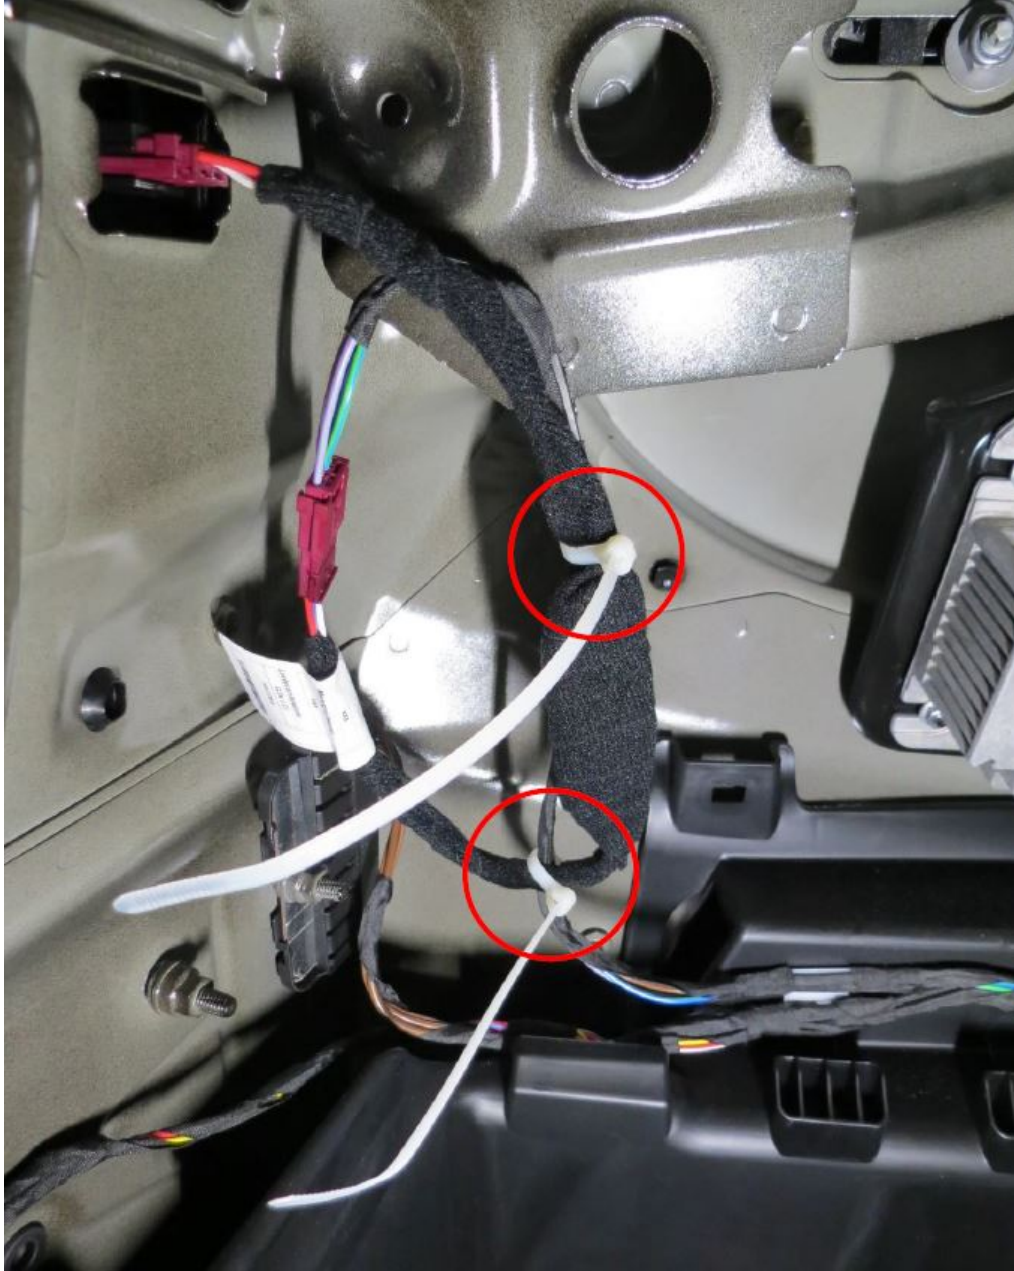
Depending on vehicle voltage demand, a voltage drop may occur to the left taillight, causing a check control message without any functional defect of the light.

1. Referencing ISTA repair instructions REP 63 21 275, complete the preliminary steps (1-3) only to gain access to the left taillight. It is not necessary to completely remove the taillight.
2. Unplug the connection to the left taillight.
3. Familiarize yourself with the connector identification (A or B) of the adapter harness P/N 61 11 5A3C023 as shown below.
