EXCESSIVE CONDENSATION IN HEADLIGHT

E-Series	Model Description	Production Date
G22	4 Series Coupe	Before March, 2022
G23	4 Series Convertible	Before March, 2022
G26	4 Series Gran Coupe	Before March, 2022
G80	M3 Sedan	Before March, 2022
G82	M4 Coupe	Before March, 2022

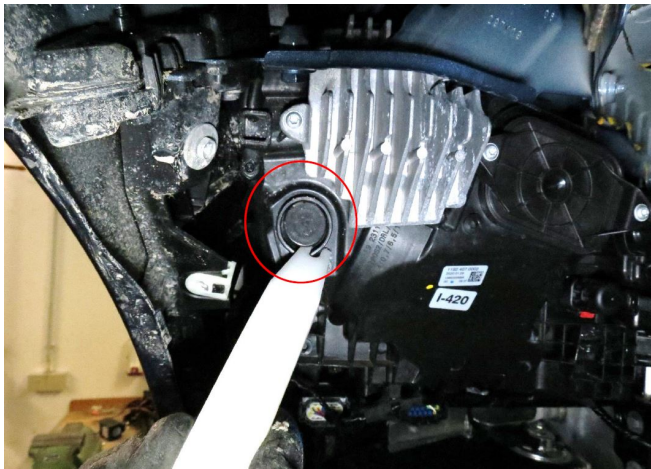
1. Remove the wheel arch trim from both sides of the vehicle following ISTA repair instructions **51 71 038** “Removing and installing front left or right wheel arch cover (front section)”.

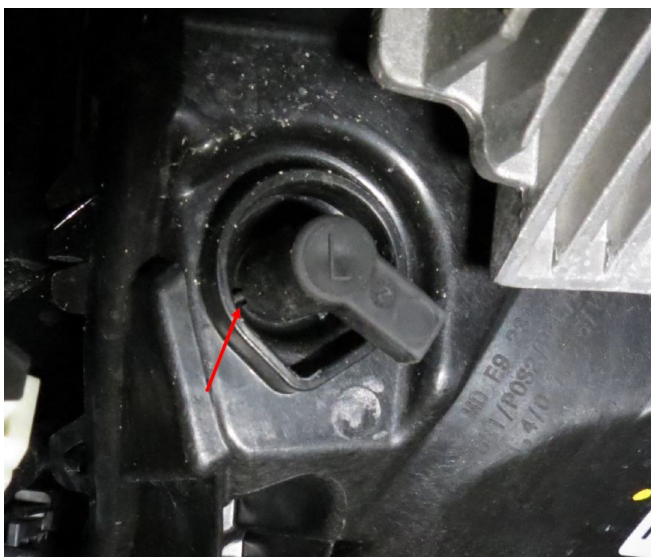
2. Using a suitable tool, remove the outer covers from each headlight.

3. Install the updated vents on both sides.

Note: The updated vent is notched to align with a rib on the headlight. Ensure the vent is aligned and fully seated onto the headlight.
