## CONDENSATION IN TAILLIGHT

G05 (X5 Sports Activity Vehicle)	G06 (X6 Sports Activity Coupe)	G07 (X7 Sports Activity Vehicle)	G14 (8 Series Convertible)
G15 (8 Series Coupe)	G16 (8 Series Gran Coupe)	G20 (3 Series Sedan)	G22 (4 Series Coupe)
G23 (4 Series Convertible)	G29 (Z4 Roadster)	G80 (M3 Sedan)	G82 (M4 Coupe)

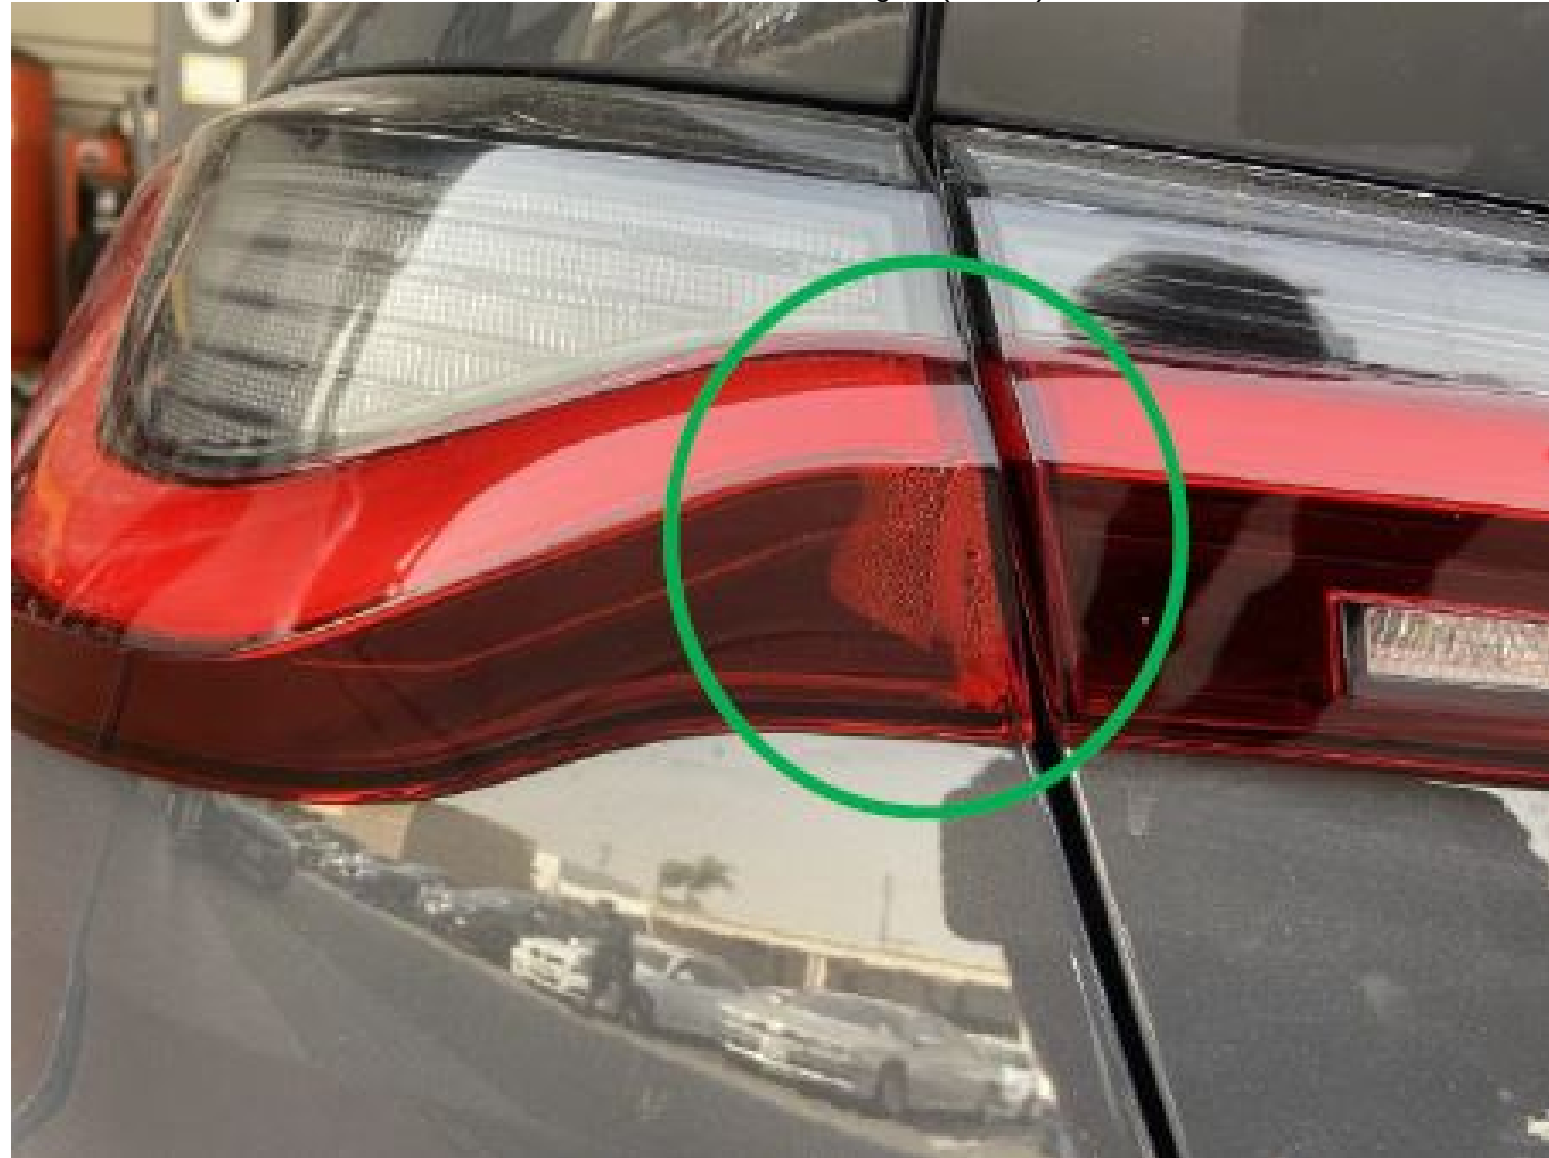
Condensation is present on the inner surfaces in one or both taillights (circled).

Modern BMW vehicles utilize waterproof membrane technology which allows for naturally occurring condensation and air to escape, without allowing excess water or dirt entry. Vehicles which utilize this membrane technology will dry normal condensation at a slower rate than open concept taillights used on previous models. This is a normal condition and requires no correction.

The condensation shown will typically form along the geometrical edges or corners of the taillight lenses. This is a normal characteristic of modern taillights and requires no correction, as this is not a defect.
