G12 (7 Series)

G30 (5 Series Sedan)

With SA 552 (Adaptive LED headlight) option

CCM (Check Control Message) with Adaptive Light Systems Defect appears on Control Display. During the vehicle test one or more fault codes are stored in the left or right FLM01 (Front Light Module).

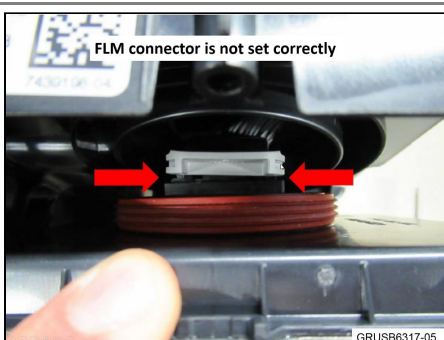
1. Perform a vehicle test, one or more above fault codes listed. Always connect a BMW approved battery charger/power supply ([SI B04 23 10](#)).
2. Remove affected headlight as per repair instruction REP 63 12 003 "Removing and installing left or right headlight".
3. Remove FLM01 from the headlight.
4. Inspect the control unit connector for a tight fit.

**Is the connector tightly fit to the control unit?**

**YES-** continue standard fault diagnosis

**NO –** Go to step 4.

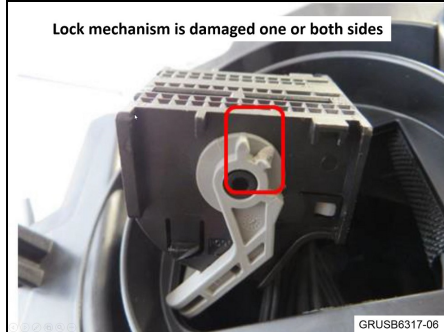
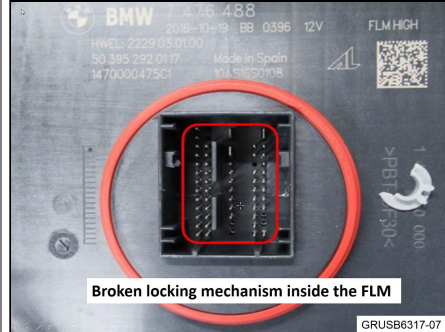
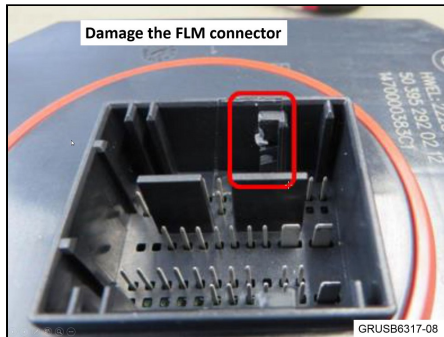
The lock mechanism from the headlight harness connector is not aligned correctly which can damage the control unit for front light electronics/LED highlights and/or the headlight.

4. Remove the connector and inspect for damage – broken latch clip, scorched contacts

YES - replace the headlight assembly and the control unit refer to which connector is damaged area.

NO – reconnect the circuit verifying latch mechanism is functional.
