## RECALL 20V-528: HEADLAMP (SCENIC-LIGHT) LENS

This Service Information Bulletin (Revision 4) replaces SI B63 04 20 **dated September 2020**.

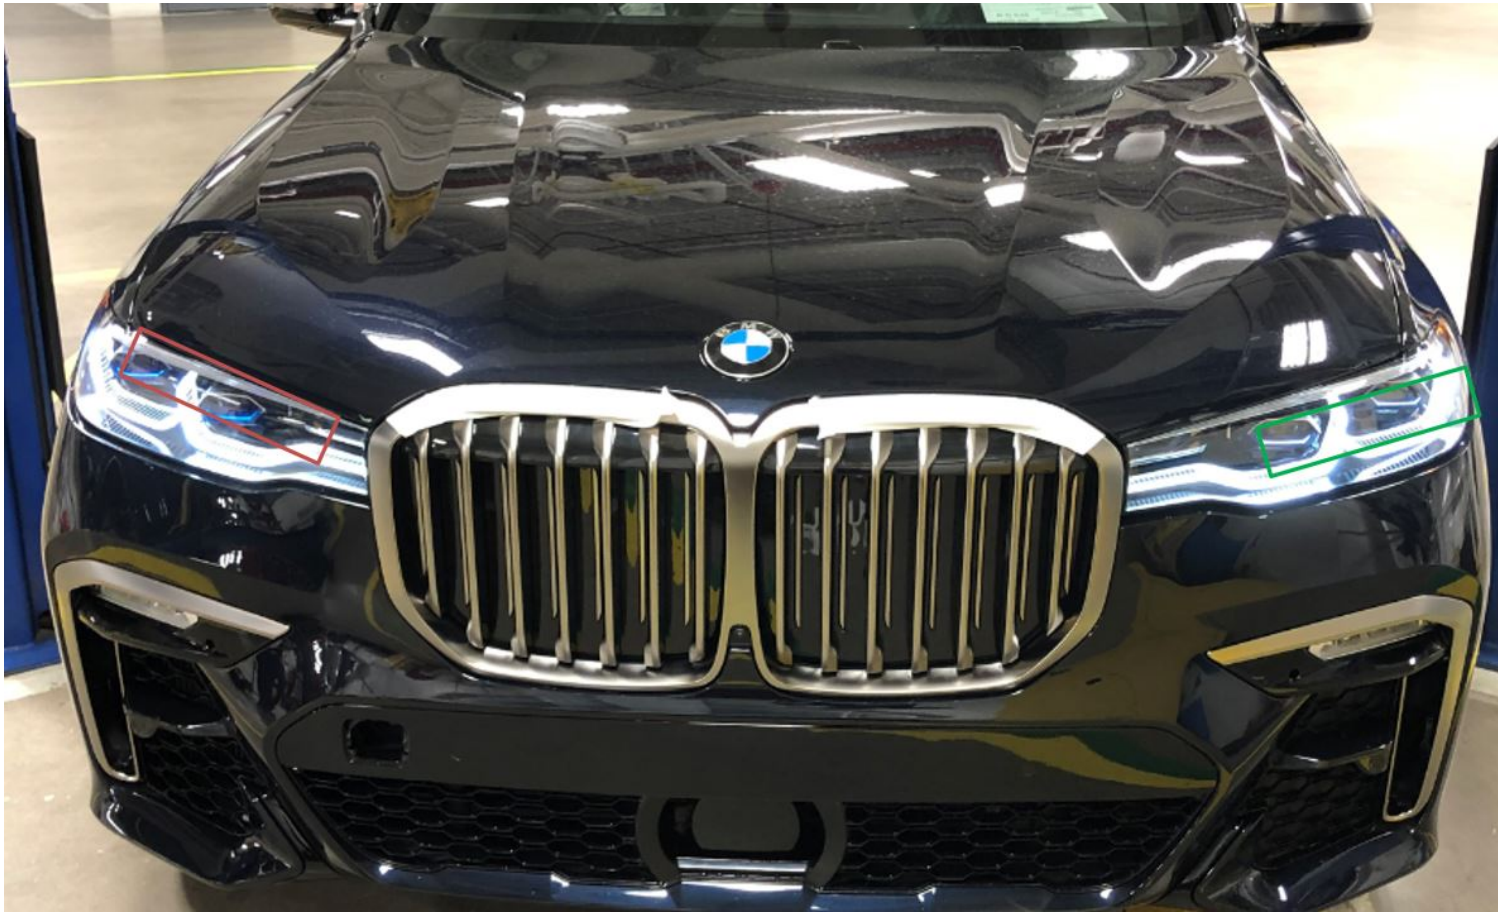
The left and/or right headlamp may contain a specific version of the “scenic-light” lens which allows for blue light to illuminate. This lens may not meet a Federal requirement, because the blue light is outside of the allowable light color spectrum.

The incorrect headlight(s) may have been installed during production.

2. Inspect the color of the light emitted from the X shaped finisher within the headlight. The photo below shows an example of a vehicle with one blue light on the passenger side (NOT OK) and one white light on the driver side (OK).

**No:** Replace whichever headlight is emitting the blue light following the applicable repair instructions within ISTA for the model of vehicle being repaired.

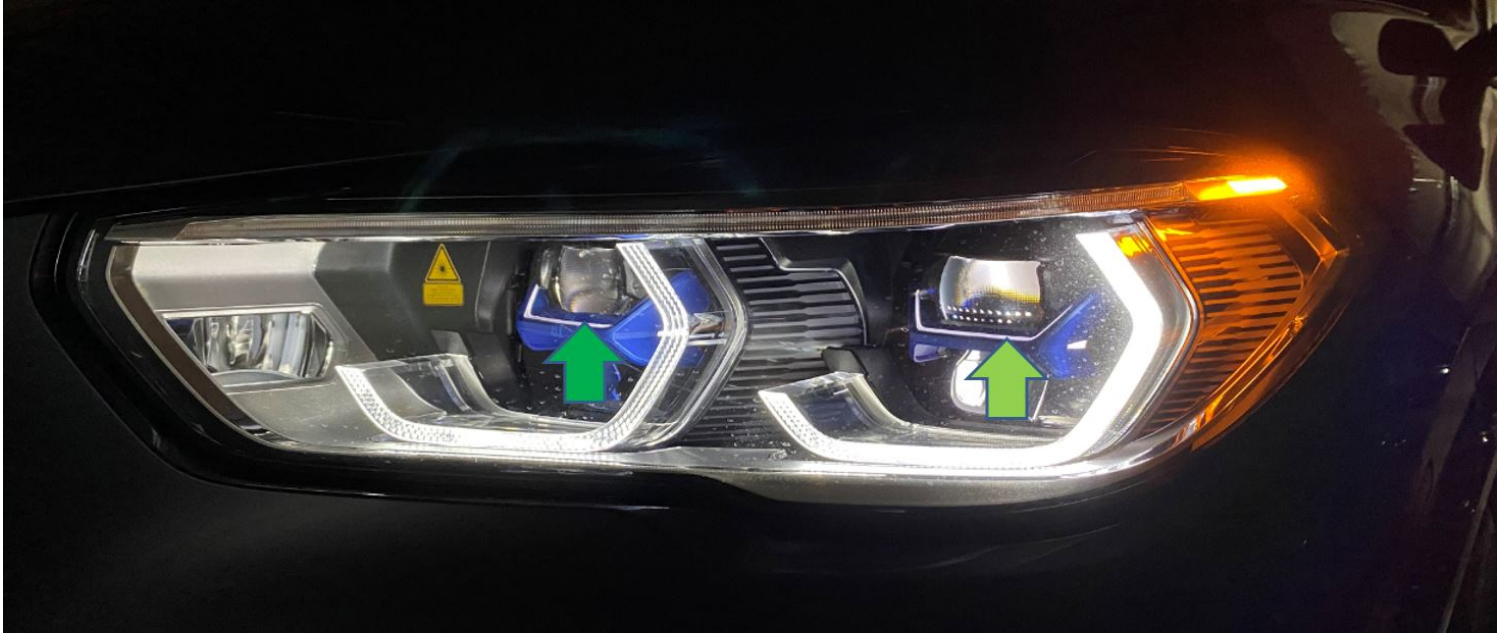
The photo below showing a white (OK) scenic light inspected in dark conditions.
