This Service Information bulletin supersedes SI B63 06 11 **dated February 2012.**

## MODEL

| E46/4 (3 Series Sedan) produced from 9/1/01 to 02/01/05 |

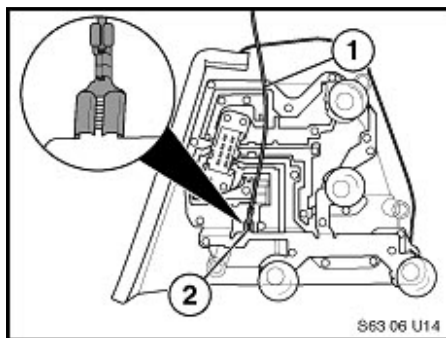
1. **UPDATE!** Check the operation and function of all the lamps (park lamp, turn signal, and brake lamp) for both rear lamp assemblies.
2. If all lamps **are** functioning correctly, proceed to step 5.
3. If the lamps within either tail lamp assembly **are not** functioning, inspect the wire harness connectors (left side connector X319 and right side connector X318) for thermal damage.

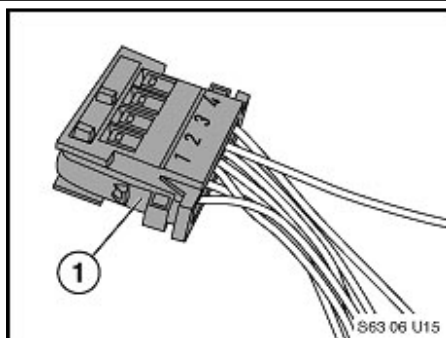
## **UPDATE!** If thermal damage is found:

4. **UPDATE!** Replace the 8-pin connector socket housing and all 7-pin connectors for the malfunctioning side(s) only.
- See the 8-Pin Connector Socket Housing Replacement procedure.

Remove the socket housing (1) (X338 and/or X339): Refer to ISTA (Integrated Service Technical Application) Repair Instructions **REP 63 21 055** "Replace the socket housing for the left-hand or right-hand rear light (side panel)."

Make note of the pin assignments and wire colors. Remove the harness tape about 150 mm from the 8-pin socket housing. Cut the cables off directly flush with the 8-pin socket (connector) housing X319 and/or X318 as needed. Replace the socket housing and all the (7) connector terminals, only for the defective side. Clean the connectors on the light carrier to improve a good contact to the other circuits.

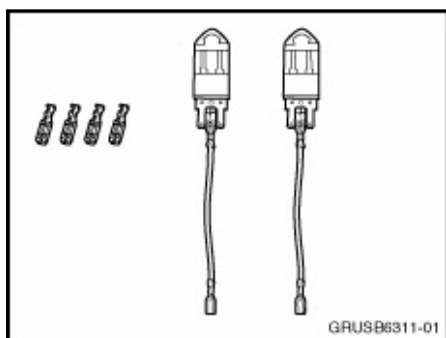
5. **UPDATE!** If both rear lamp assemblies **already** have an additional repair kit ground cable (1) on the bulb holder (2) (see diagram – bulb holder is removed):

**No further repair is necessary.**
