G01 (X3)
Produced from 8/1/2017-12/21/2018

Cracks may be present in the rear lights mounted to the tailgate.

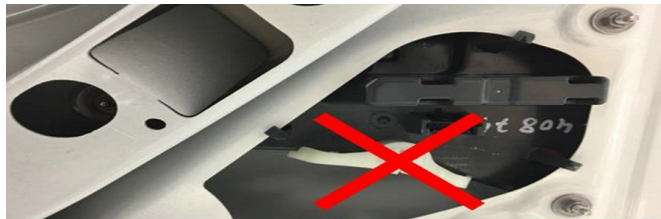
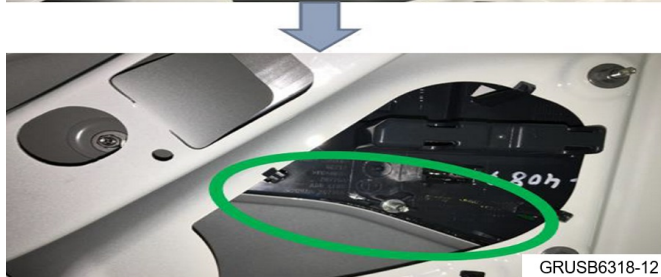
Stress caused by an additional mounting bracket.

During installation, do not re-install the lower mounting bracket shown below. This will reduce the stress that is causing the cracks to occur.

Replace cracked rear lights with modified installation instructions.

Replace one or both cracked rear lights following repair instructions REP 63 21 285 "Remove and install both rear lights of tailgate". Only replace a rear light if it is cracked.
