E-Series	Model Description	Affected Option Code
G01	X3 Sports Activity Vehicle	4UR Ambient Lighting
G02	X4 Sports Activity Coupe	4UR Ambient Lighting
G05	X5 Sports Activity Vehicle	4UR Ambient Lighting
G06	X6 Sports Activity Coupe	4UR Ambient Lighting
G07	X7 Sports Activity Vehicle	4UR Ambient Lighting

The LED light on the front door is not working. Depending on the model, the location of the light will be different.

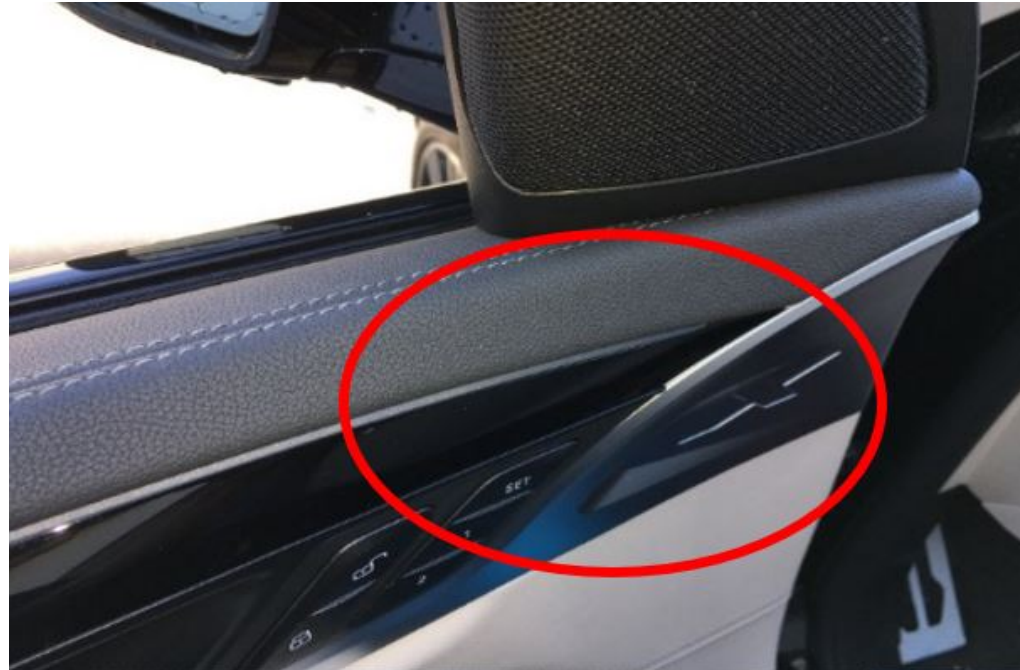
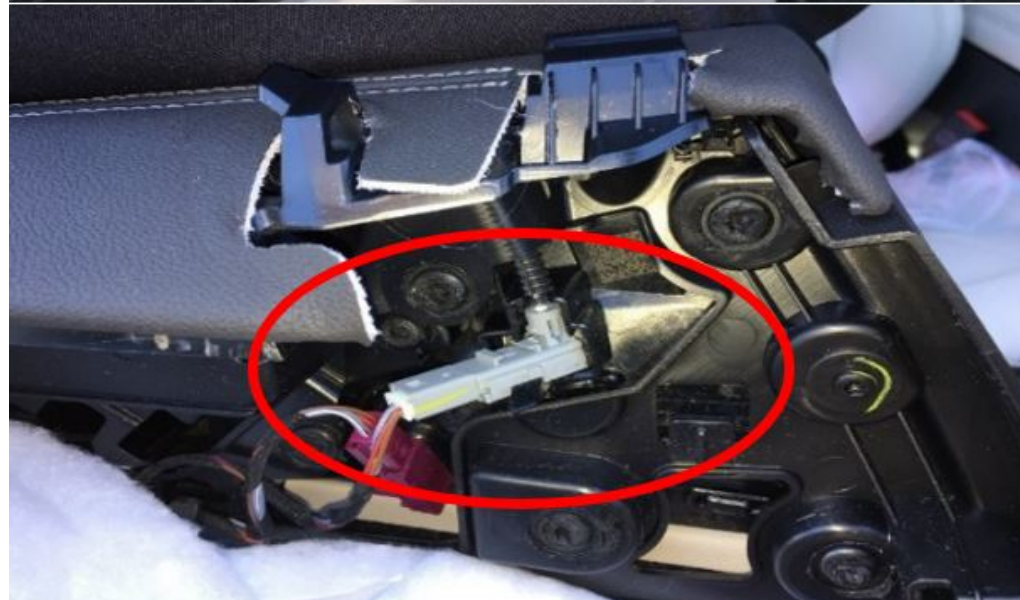
G01 and G02 location shown below:

Due to the orientation of the LED module, moisture may enter the LED module, causing corrosion.

Replace the affected LED module and seal the replacement LED module.

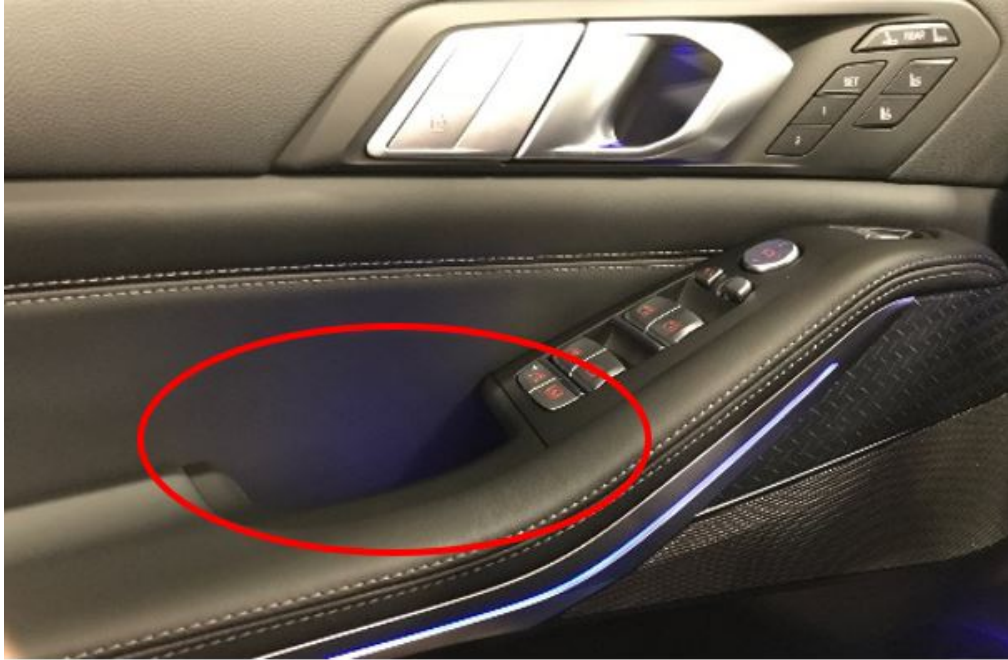
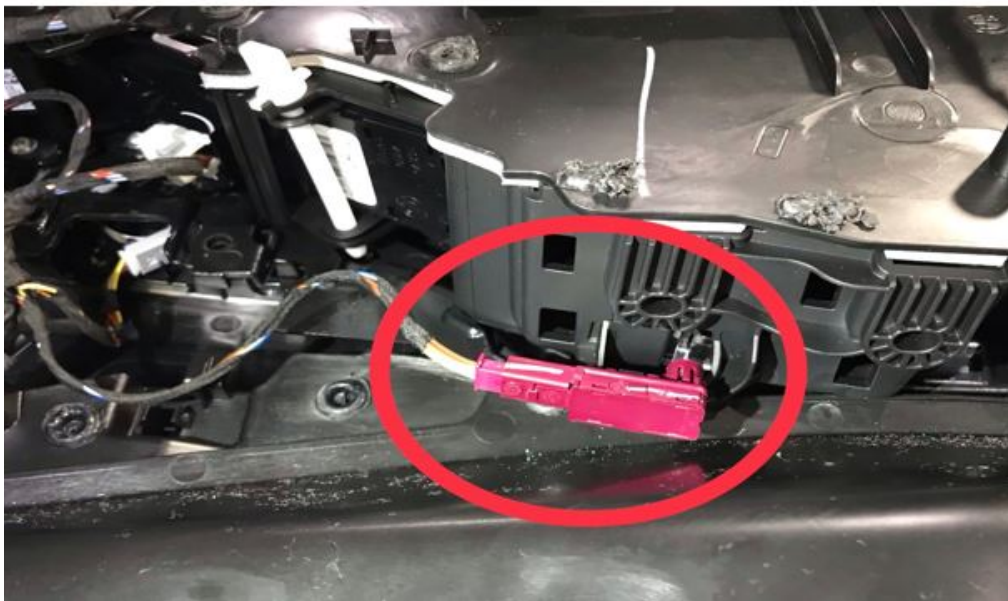
G05, G06, and G07 shown below:
