## REAR TAIL LIGHT FAILURE

F30 (3 Series Sedan)	F31 (3 Series Sport Wagon)	F32 (4 Series Coupe)	F33 (4 Series Convertible)
F34 (3 Series Gran Turismo)	F36 (4 Series Gran Coupe)	F80 (M3 Sedan)	F82 (M4 Coupe)
F83 (M4 Convertible)

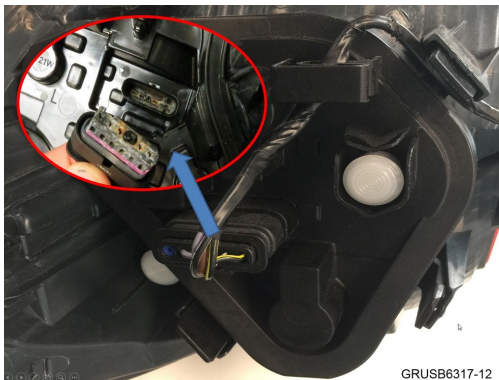
Burnt pin in connector from wiring harness to rear lamp assembly bulb holder.

3. Inspect the condition of the pins on the harness connector and on the bulb holder.  
**Do any of the pins appear to be burnt?**

**YES-** replace the bulb support according to REP 63 21 030 Removing and installing/replacing left socket housing for rear light (on side wall) and wiring harness connector then go to Step 4.
