This Service Information bulletin supersedes SI B63 14 10 dated November 2010.

| E89 | Produced from January 31, 2009 to November 24, 2012 |

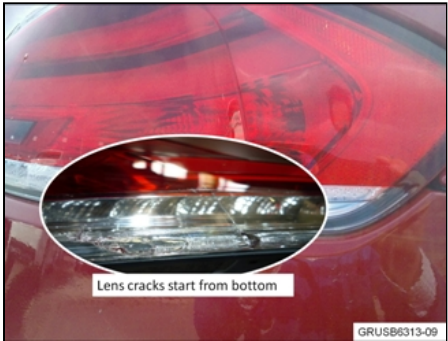
| | Condensation builds up inside the taillight lens. |

The rear taillight has cracks due to torsion stress (contact between the body and lens). The cracks provide a path for water to enter the taillight.

1. Inspect the rear taillight for any damage caused by outside influences or impact. Outside influences or impact is not covered under warranty
2. If no outside influences are found, replace the defective side taillight using ISTA Repair Instruction REP 63 21 170, "Removing and installing / replacing left or right rear light."
