WINDSHIELD MISTS OVER AFTER DEPARTURE / NOISES IN THE RECIRCULATED AIR FLAP AREA

F39 (X2 Sports Activity Coupe)	F44 (2 Series Gran Coupe)	F48 (X1 Sports Activity Vehicle)	F90 (M5 Sedan)
F95 (X5 M Sports Activity Vehicle)	F96 (X6 M Sports Activity Coupe)	F97 (X3 M Sports Activity Vehicle)	F98 (X4 M Sports Activity Coupe)
G01 (X3 Sports Activity Vehicle)	G02 (X4 Sports Activity Coupe)	G05 (X5 Sports Activity Vehicle)	G06 (X6 Sports Activity Coupe)
G07 (X7 Sports Activity Vehicle)	G12 (7 Series Sedan)	G14 (8 Series Convertible)	G15 (8 Series Coupe)
G16 (8 Series Gran Coupe)	G20 (3 Series Sedan)	G22 (4 Series Coupe)	G23 (4 Series Convertible)
G26 (4 Series Gran Coupe)	G29 (Z4 Roadster)	G32 (640i xDrive Gran Turismo)	G42 (2 Series Coupe)
G80 (M3 Sedan)	G82 (M4 Coupe)	G83 (M4 Convertible)	I20 (iX Sports Activity Vehicle)

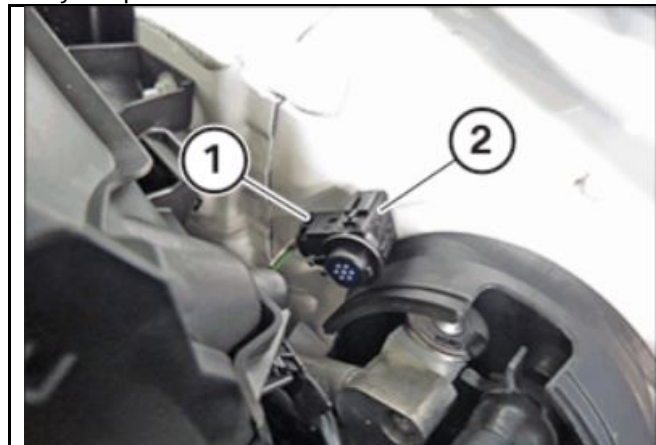
Verify the part number of the installed automatic air recirculation control sensor.

If part number **64 11 5 A3F 255** or **64 11 5 A3F 250** is installed, this must be replaced by a new automatic air recirculation control sensor. Follow ISTA Repair Instruction **REP 64 11 991** "Removing and installing sensor for automatic recirculation air control"
