SIB 64 03 20 2021-10-04

CENTER CONSOLE / CUP HOLDER GETS HOT WHEN THE HEAT IS ON

This Service Information Bulletin (Revision 1) replaces SI B64 03 20 dated September 2020.

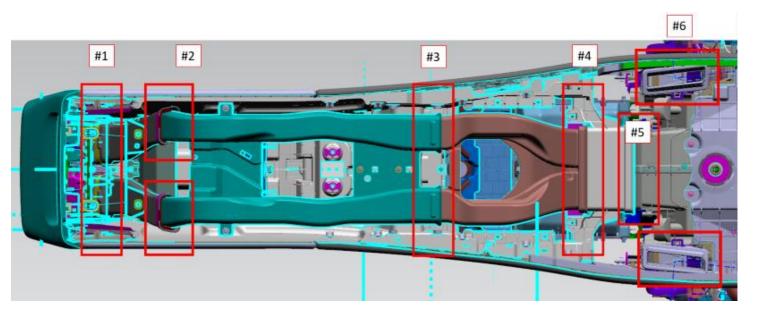
The air ducts may not be properly connected, this allows heated air to leak out in this area.

The foam material that seals between the ducts may be out of position, not held by the mounting adhesive and squashed allowing for an air leak. This leak can occur at any of these 6 junction locations:

- 1-Check foam seal material at duct connections and replace foam as needed. Ensure ducts are properly overlapped on installation.
- 2-Replace rear air ducts.

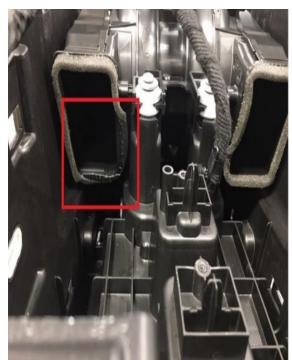
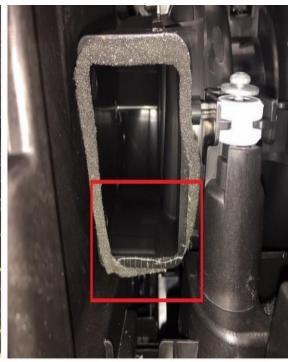
1. Check whether the air ducts beneath the center console are properly assembled. They should overlap when installed.

If one or more air ducts are not properly mounted or connected, disassemble these and install them correctly.

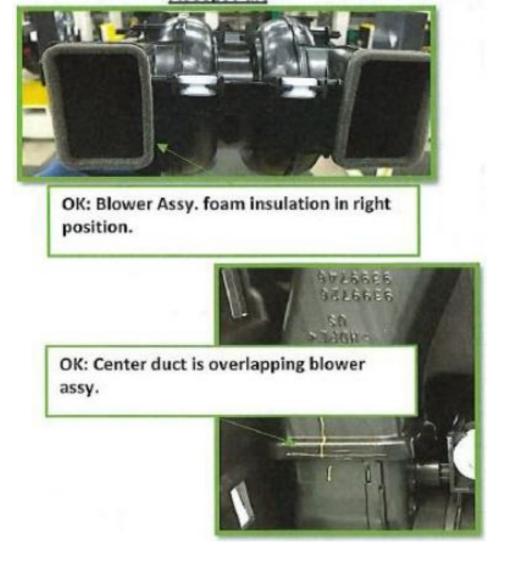
Not OK: Blower Assembly foam insulation found rolled, not positioned in correct, location allowing air to leak.

2. Check if the foam material to the next connecting piece is correctly installed. If damaged install a locally sourced, one side self-adhesive

HVAC foam. (The foam seal comes assembled on new parts and is not available separately in the BMW parts system).

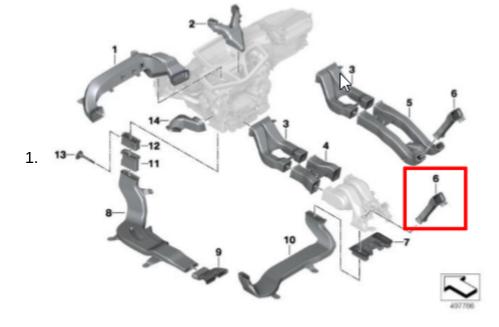
To improve interior acoustic levels and circulate some air into the console, the rear air ducts with part number 51 16 9 399 775 (left side) and 51 16 9 399 776 (right side) are utilized on the G07 and optionally on the G05. These ducts have a hole that is covered in fleece material.

To maximize heat reduction within in the center console, the rear air ducts with part number 51 16 9 399 775 (left) and 51 16 9 399 776 (right) **must be replaced in all cases** with base model rear air ducts with part number 51 16 6 833 469 (left) and 51 16 6 833 470 (right).

NOTE: By installing the base model rear air ducts with part number 51 16 6 833 469 (left side) and 51 19 6 833 470 (right side) these fleece cutouts are removed maximizing the heat reduction in the center console. **The base ducts may impact acoustics of rear HVAC.**
