AIRFLOW RATE IN THE VEHICLE INTERIOR IS TOO LOW

This Service Information Bulletin (Revision 3) replaces SI B64 03 21 **dated July 2021**.

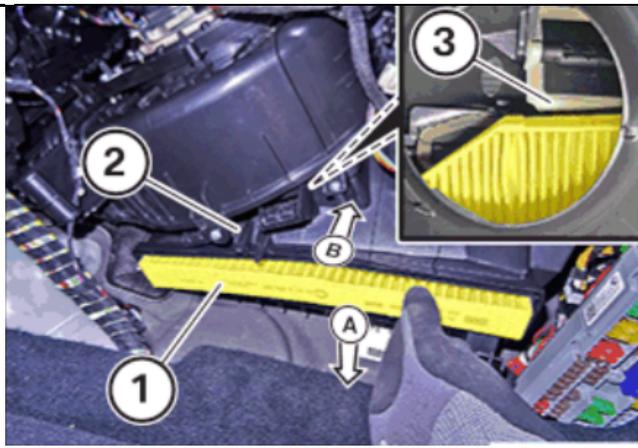
<p>1. Activate the air recirculation function by pressing the recirculation button on the climate control panel (Recirculation mode, circled), LED ON. This will close the top fresh air flap leaving the bottom two recirculation flaps open.</p> <p>NOTE: It is the top flap which is in danger of being damaged during microfilter service.</p>
	<p>2. This can be confirmed in the Central Information Display (CID) in the Climate Control Menu (MENU A/C) under AIR QUALITY.</p> <p>Ensure the flap is set to Air recirculation so the top flap (fresh air inlet) sits flat and does not interfere with microfilter removal.</p>

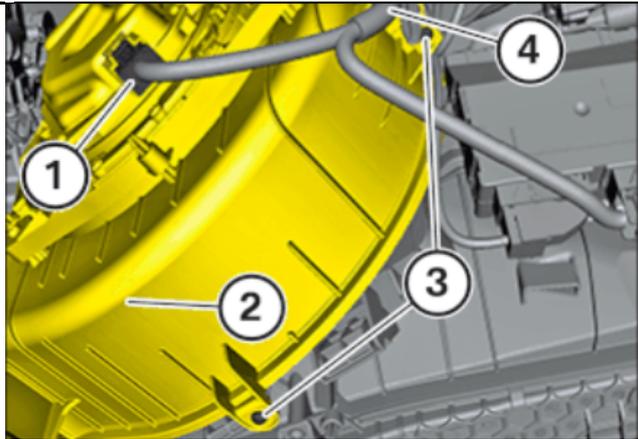
3. Dismantle the microfilter

See **REP 00 00 616** Service microfilter.

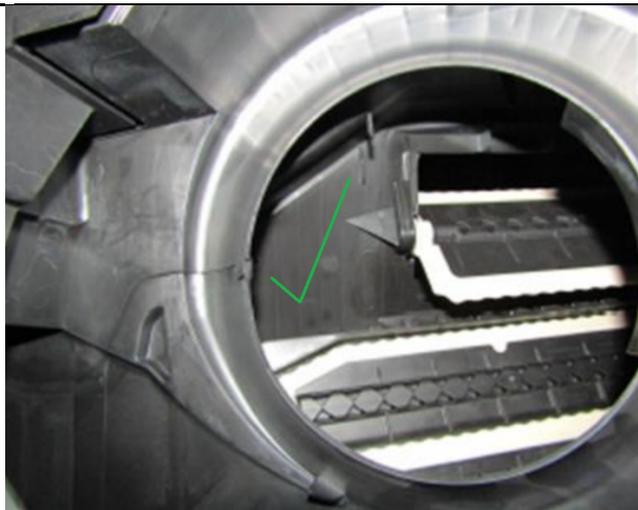
4. Remove the ventilation system blower motor.

See **REP 64 11 213** Removing and installing/replacing heater/air conditioner fan.

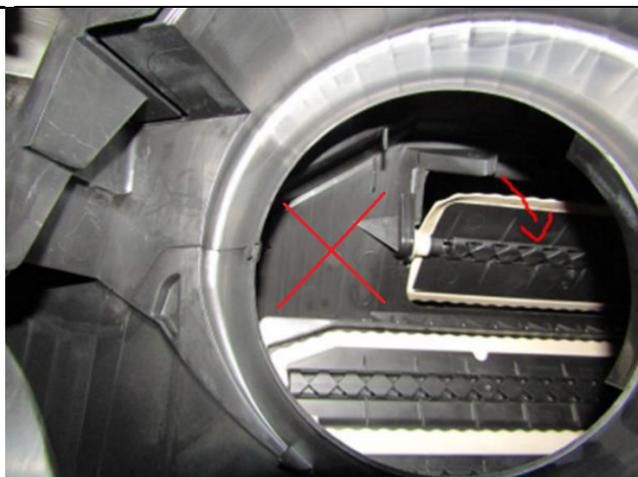
The fresh air flap can be over-driven (pushed past its normal end stop) when the microfilter is replaced. The regular opening and closing of the fresh air flap can no longer be guaranteed.

5. Check correct position of the fresh air flap through the blower motor opening, or using a borescope from the microfilter opening
(NOTE: This flap is the top of three flaps).

Activate and deactivate the fresh air/air recirculation function on the air conditioning control panel or CID menu and observe whether the functionality of the flap is OK.

6. If the flap system is not OK, try to correct the flap by hand. See direction of arrow.

7. Once moved back past the end point, the flap **may** not function properly.

- After moving flap manually, use the test plan ABL to re-initialize/address the stepper motor position
- Allow vehicle to enter sleep mode after running the test plan prior to testing flap positioning

- If still not operational, then you may have to remove the stepper motor to check for damage. Once repaired run the ABL to initialize the stepper motors and allow the vehicle to enter sleep mode before testing.
