E-Series	Model Description	Production Date
G05	X5 Sports Activity Vehicle	From Start of Production (SoP)

Moisture in the driver footwell and/or passenger footwell when the air conditioning (A/C) is activated.

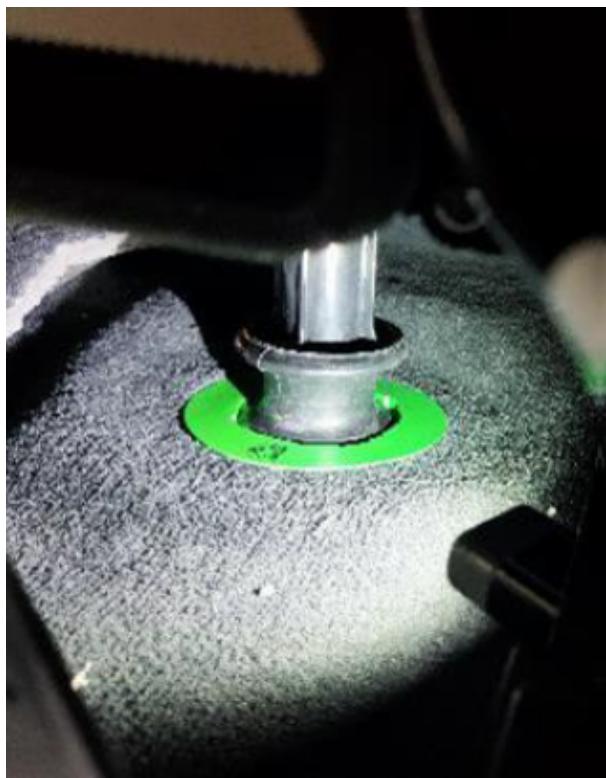
Pictured is the correct installation of the drain hose.

Check the condensation water drainage hose of the air conditioning system for correct routing and connection.

Closely examine the connection point just above the center tunnel (centrally below the instrument panel) and reconnected if necessary.

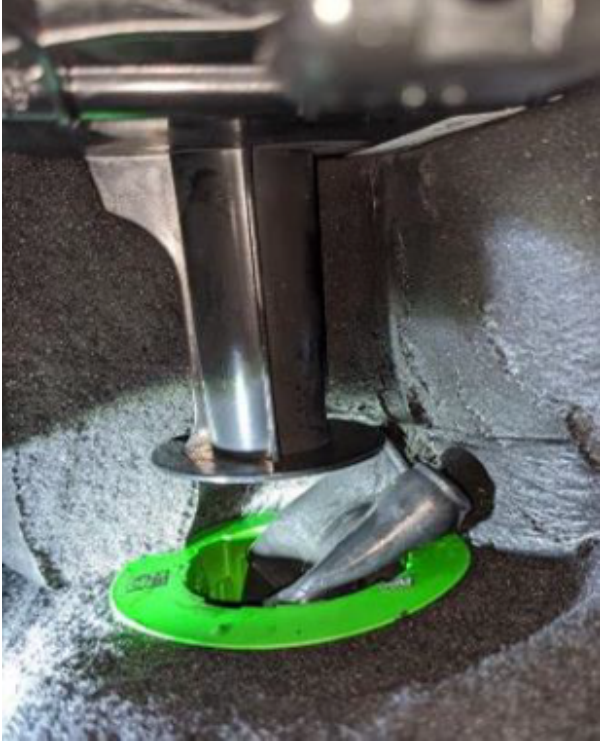
2. Here the drain hose is folded over and will require replacement to seal properly.

If the condensation water drainage hose is damaged, replace it.

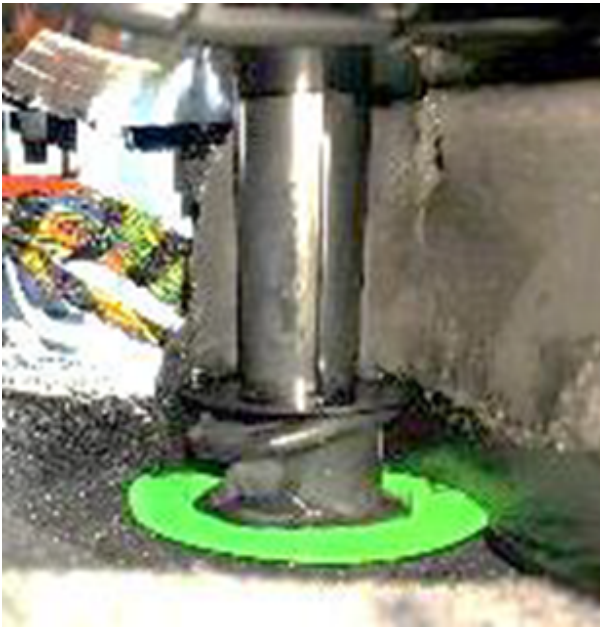
3. Here the drain hose is incorrectly installed and will require replacement to seal properly.
