RATTLING NOISE PERCEPTIBLE IN VEHICLE INTERIOR WITH AC ACTIVATED

This Service Information Bulletin (Revision 2) replaces SI B64 05 21 **dated April 2022**.

E-Series	Model Description	Production Date
G20	3 Series Sedan	Start of Production up to May 30, 2025

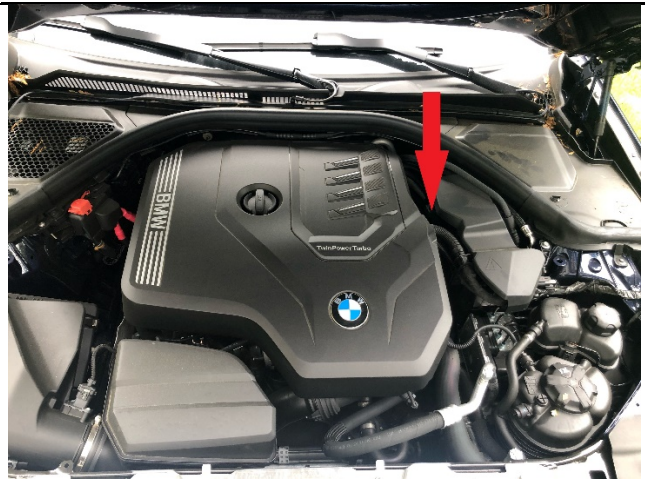
The refrigerant line double pipe and a clamp on the return line of the internal heat exchanger are in line with each other (in the direction of travel, on the left (driver) side of the engine compartment below/behind the DME) and are making contact.

<p>The hoses are contacting here (arrow).</p>
	<p>Mount a spacer (part number 11 53 7 537 923) in the engine compartment between the coolant hose feed and coolant hose return. The coolant hoses have to be turned about 10 to 15 degrees in the direction of the bulkhead.</p>

Insert a spacer between the coolant hoses underhood, and strips of felt tape in the area of contact between lines below the instrument panel.

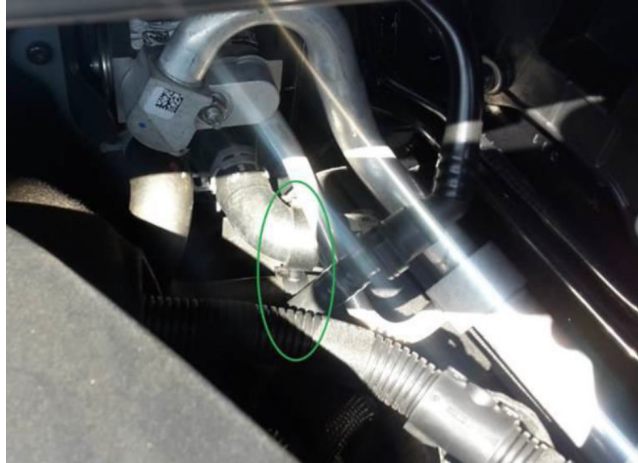
Close up view of spacer installed.

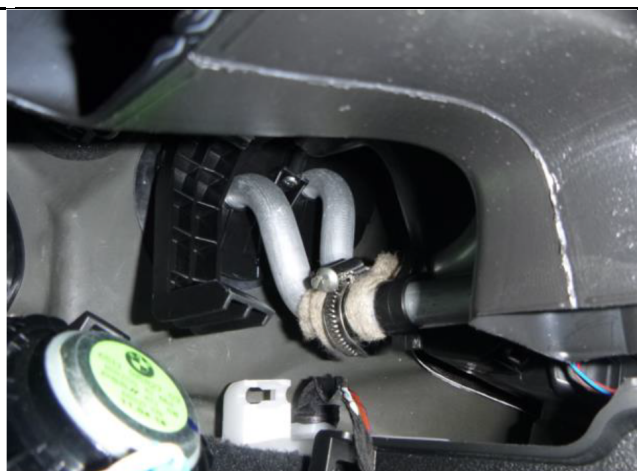
This prevents the lines moving in the aperture grommet.
See attached video:
[BV64 02 22_G20 Drone noise source](#)

Tape the two heat exchanger lines with a felt strip (part number: 51 45 2 353 024) 4-5 inches (10-12 cm) long around each of the lines. Secure the lines together using a worm-type hose clamp (part number 07 12 9 952 117).

Then remount the trim panel for pedal mechanism and reassess the vehicle.
