**MODEL**

E-Series	Model Description	Production Date	Affected Option Code
F95	X5 M Sports Activity Vehicle (SAV)	From Start of Production	SA <b>534</b> automatic climate control <b>Standard on G05 G06</b> SA <b>4NB</b> 4-zone automatic climate control <b>Std on G07 F95 F96, Option on G05 G06</b> SA <b>4NN</b> 5-zone automatic climate control (Third row) <b>Option on G07</b>
F96	X6 M Sports Activity Coupe (SAC)		
G05	X5 SAV		
G06	X6 SAC		
G07	X7 SAV

The customer states that one of the front or rear climate control zones is unresponsive and either gives too cold or too warm air regardless of IHKA setting.

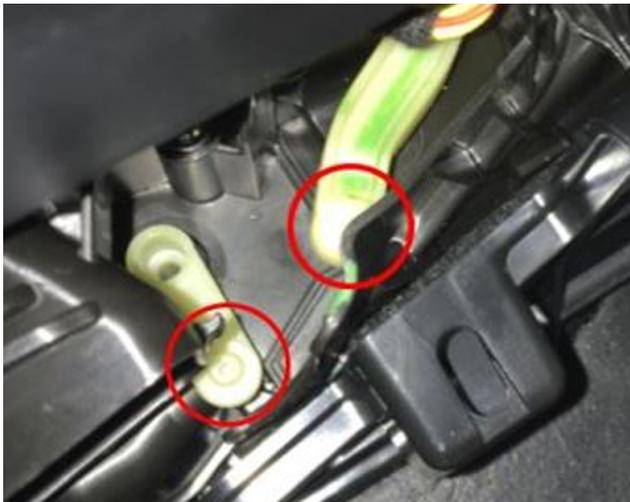
**Failure Mode 1:** One connection of the external lever assembly has disconnected. There is a plastic “mushroom-shaped” retainer on one link that locks into the other.

Set timing between linkage and air flap if necessary. Reattach the linkage and calibrate the stepper motor.

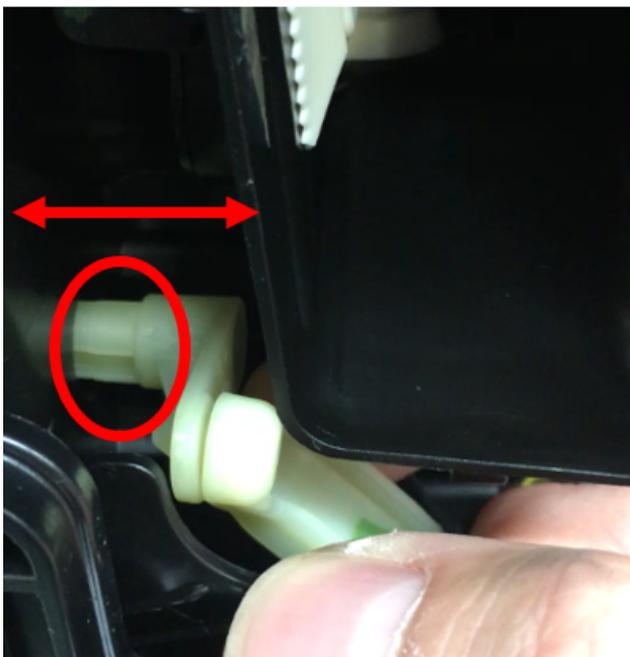
**Failure Mode 2:** The external lever assembly has become disconnected from the flap within the IHKA box. It should not be able to move left and right when properly connected.

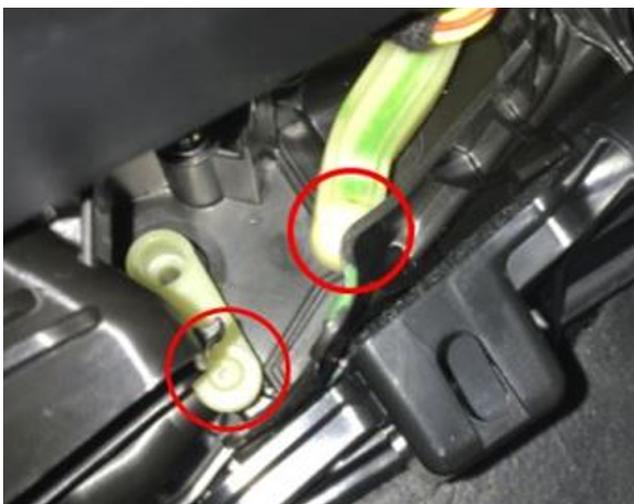
**Failure Mode 1:** One connection of the external lever assembly has disconnected. There is a plastic mushroom shaped retainer on one link that locks into the other.

Press the two links together to interlock.

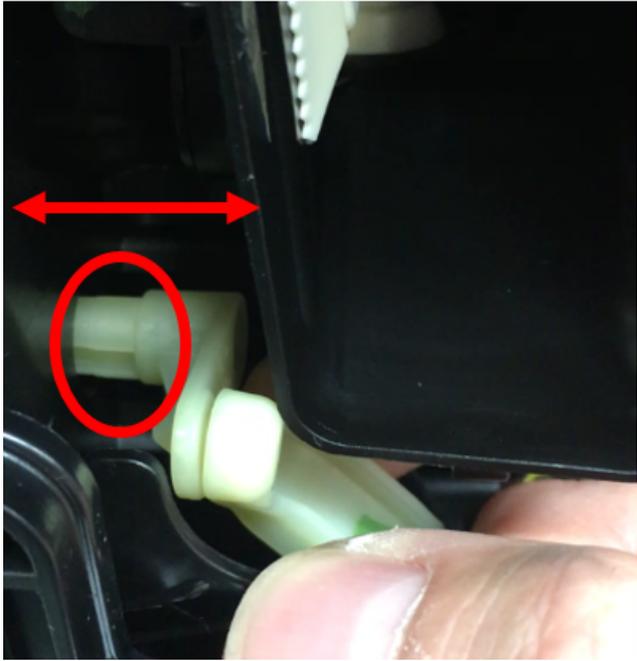
**Failure Mode 2:** The external lever assembly has become disconnected from the flap within the IHKA box. It should not be able to move left and right when properly connected.

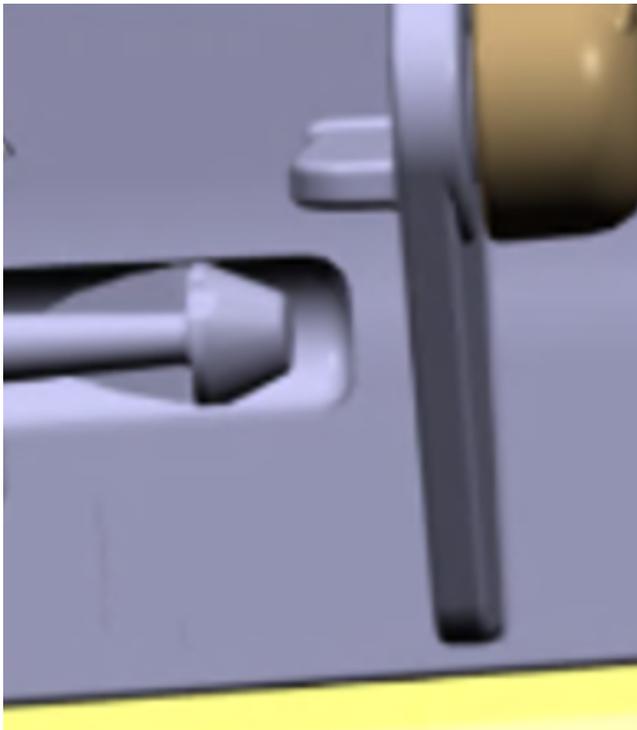
The end of the linkage has a mushroom shaped plastic retainer that interference-fits into the flap within the IHKA box.

- Check timing of the flap door by moving the linkage full travel and verifying the flap moves open/closed
- If the timing is off, rotate the linkage prior to locking into the flap

Push linkage back into flap assembly until you hear/feel it 'click' into place.

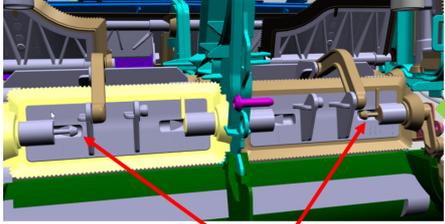
„Click“ connection with the flap.

Push until  
hear the  
„click“
