## IHKR Blower Resistor Assembly Failure

B 64 05 92 (3503)

**SUBJECT:** IHKR Blower Resistor Assembly Failure

**MODELS:** E36 (prior to 9/91 production)

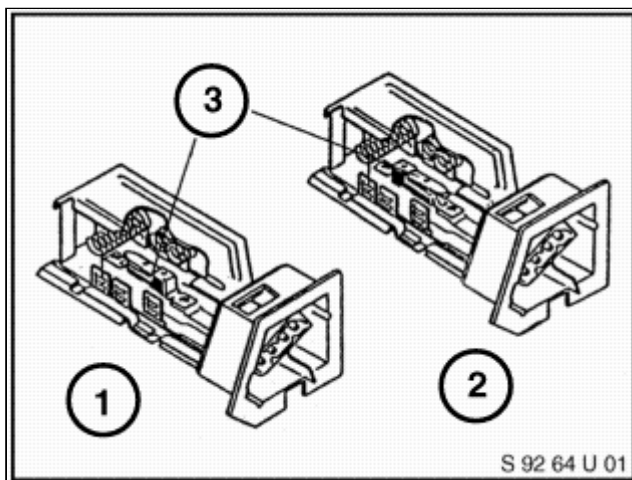
**Cause:** The support plate of the blower resistor block can heat up, causing an increase in resistance to the thermal switch. As a result, the switch heats up even more and eventually opens. The unit has been redesigned, and orients the thermal switch 180 degrees in position as compared to the older style. Refer to illustration.

- 1. New Version
- 2. Old Version
- 3. Thermal Switch

**Correction:** If one of the above complaints is experienced, replace the blower resistor unit.
