This Service Information Bulletin (Revision 11) supersedes SI B64 06 13 **dated December 2020**.

MODEL

SITUATION

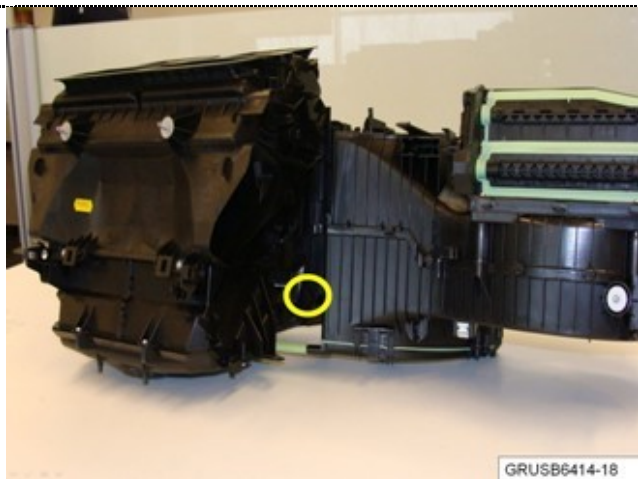
4. The IHKA housing (removed for clarity) shown is viewed from the passenger's side.

The circle shows the approximate location of the evaporator temperature sensor.

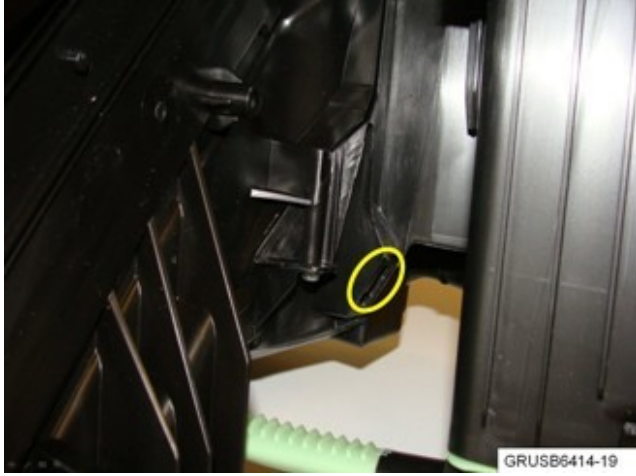
5. The close-up picture shows the exact location (circle) of the sensor opening. The following steps will be performed from the lower

passenger's footwell area at the bottom of the IHKA housing.

Note: As a reference point, the evaporator temperature sensor is located just above the white ribbed rubber water drain hose, when viewed from below.

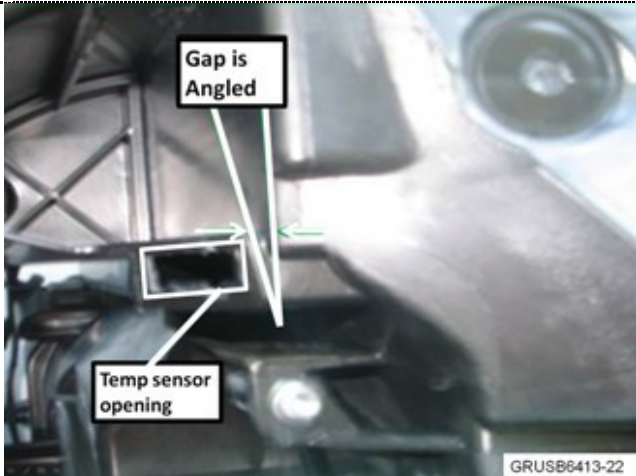
6. Locate the evaporator temperature sensor opening (sensor removed for clarity).

Check the gap between the sensor opening and the evaporator case.

If the sensor opening contact surface is slightly angled as shown, this housing is **NOT** affected by this repair procedure. In this case, proceed with normal A/C diagnostic procedures.

If no gap exists proceed to the next step.

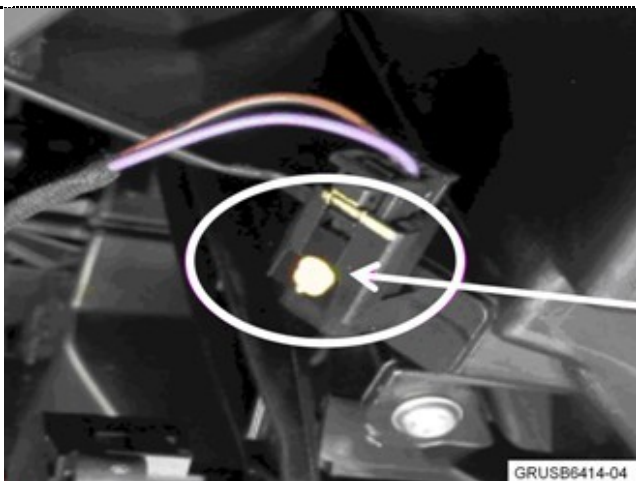
7. Check for a marking on the electrical connector.

If a mark is seen or **NO** gap exists, the IHKA housing must be modified.

Do not replace any parts. The repair procedure includes installing a new adapter to correct the gap.

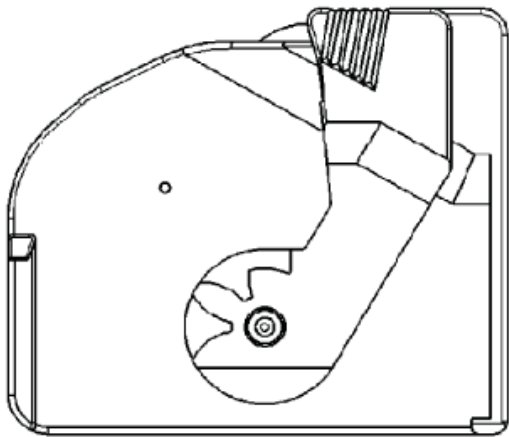
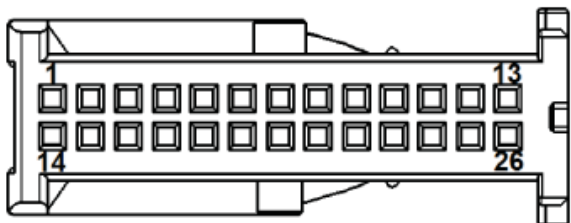
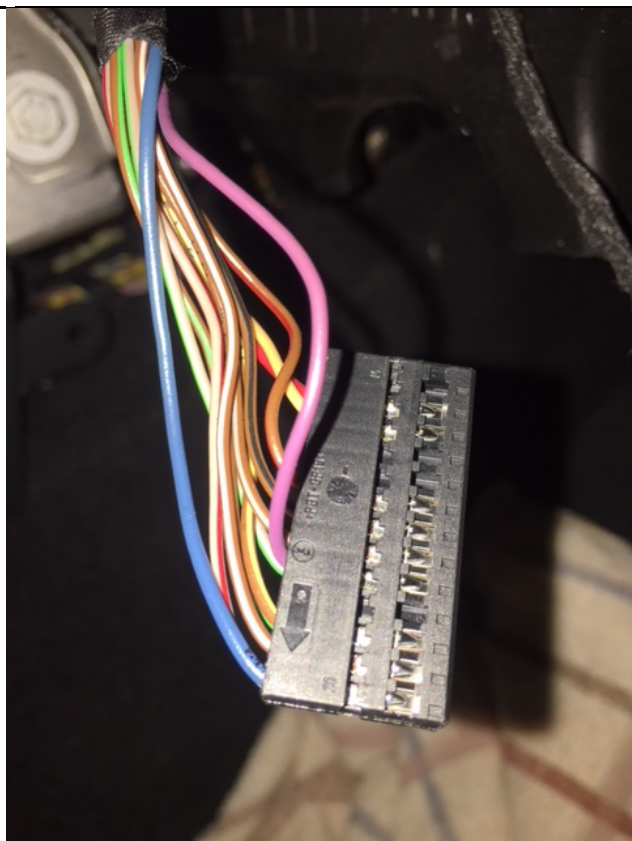
On this example vehicle (F30) the wire (pin 22) is violet colored.

The evaporator temperature sensor signal wire goes to pin 22 at IHKA control panel connector x4711.

Install resistor inline on pin 22 for the evaporator temperature sensor line at the IHKA.
