## AIR CONDITIONING COOLING IS INSUFFICIENT

This Service Information Bulletin (Revision 1) replaces SI B64 06 17 **dated November 2017**.

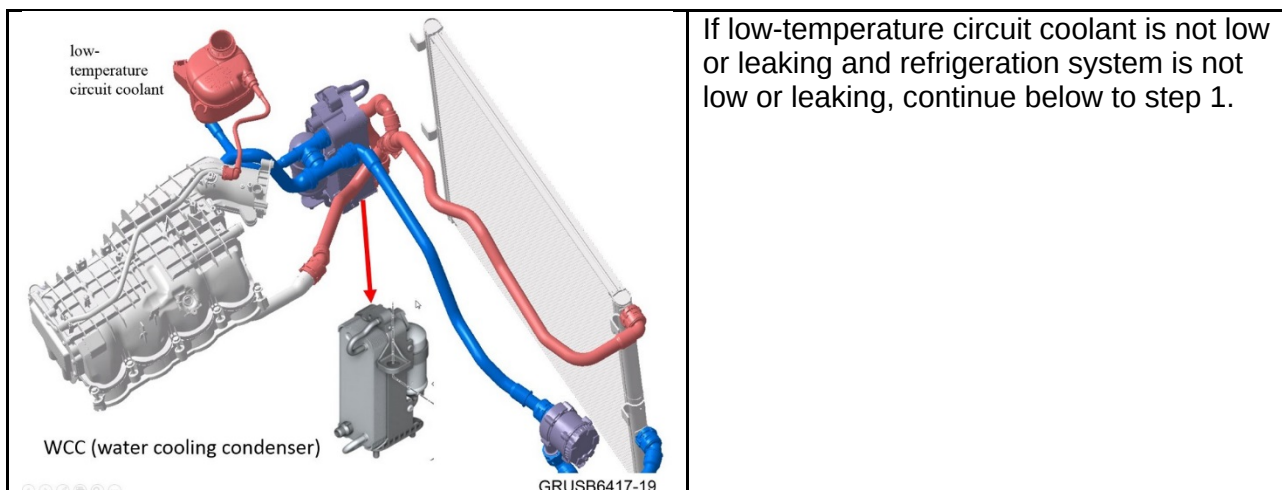
For conditions that are similar to the situation described above with Fault code in IHKA: 80120A “Air conditioning compressor: Shut-down due to excess pressure in refrigerant circuit” stored, continue to the next step below.

1. Completely drain **all** coolant from the low-temperature circuit and dispose properly based on your local regulations.
2. Evacuate the refrigeration circuit.

3. **Replace the AC Condenser WCC with the new part specified below.** Refer to ISTA 64 53 550 “Removing and installing or replacing capacitor for heating and air conditioning system”.

4. **Replace the low-temperature radiator with new part specified below.** Refer to ISTA REP 17 11 006 “Remove and install/ replace low temperature cooler”.

5. Replace the intake system with charge air cooler with new part listed below. Refer to ISTA REP 11 61 050 “Removing and installing the intake plenum”. These parts are different based on which engine is installed.
