This Service Information bulletin supersedes SI 64 07 01 dated December 2001.

## SITUATION

**UPDATE!** The potential defect involves the engine auxiliary/cooling fan in certain MY 2001 BMW vehicles, and in approx. 1550 additional MY 1998-2001 E38, E39, E46, E52, and E53 vehicles manufactured outside the above listed production range.

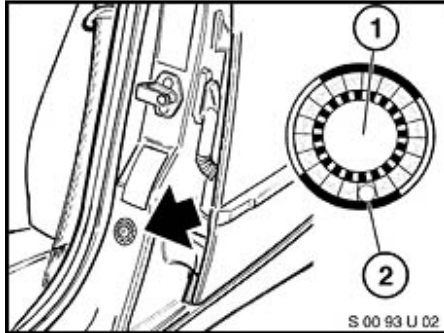
1. Check the Recall Campaign label affixed to the B-pillar:

**If the recall code number 316 is punched-out on the on the label (2), then NO further action is required.**

**If the number differs from 316, or recall label is not found, then continue with step 2.**

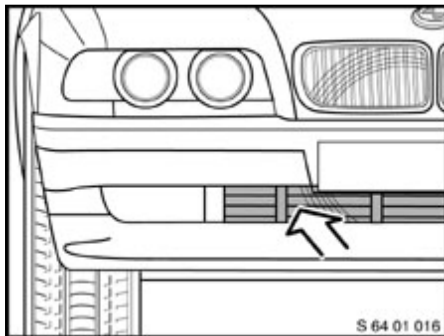
2. Check the BMW part number on the fan/shroud assembly. The part number is located on the lower right side of the shroud (molded next to the BMW logo, or on the label printed next to the logo). The number can be read from the outside, through the lower radiator grille (location indicated on the illustration).

**UPDATE!** If the part number is: 64 54 6 921 383 or 64 54 6 921 942, then NO further action is required. If the part number differs from that listed, then continue with step 3.

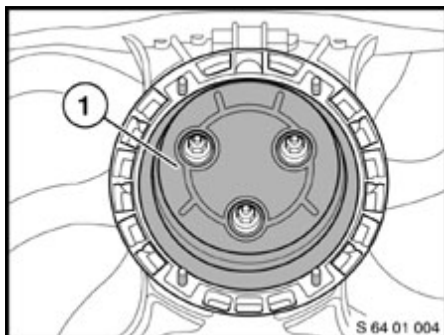
5. Remove electric auxiliary fan/shroud assembly, and inspect the back of the fan housing.

**If the motor housing (1) is solid black, without cutouts (as shown on the illustration), then NO further action is required. Reinstall all previously removed components.**

**UPDATE!** If the motor housing has cutouts and the aluminum body of the fan module can be seen, then replace electric auxiliary fan/shroud assembly with the new part - PN 64 54 6 921 942.

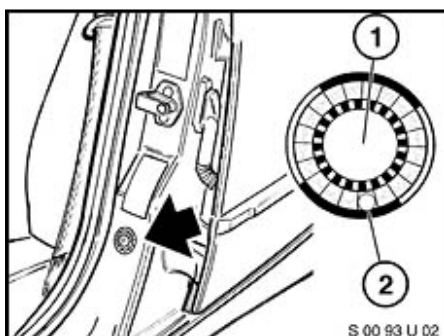
1. Check the Recall Campaign label affixed to the B-pillar:

**If the recall code number 316 is punched-out on the on the label (2), then NO further action is required.**

**If the number differs from 316, or recall label is not found, then continue with step 2.**

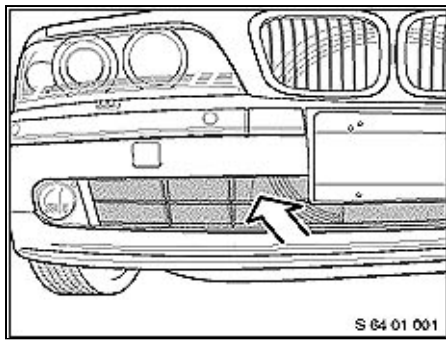
2. Check the BMW part number on the fan/shroud assembly. The part number is located on the lower right side of the shroud (molded next to the BMW logo, or on the label printed next to the logo). The number can be read from the outside, through the lower radiator grille (location indicated on the illustration).

**If the part number is: 64 54 6 921 395, then NO further action is required.**

**If the part number differs from that listed, then continue with step 3.**

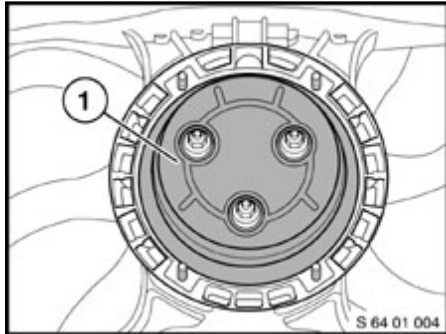
5. Remove electric auxiliary fan/shroud assembly, and inspect the back of the fan housing.

**If the motor housing (1) is solid black, without cutouts (as shown on the illustration), then NO further action is required. Reinstall all previously removed components.**

**If the motor housing has cutouts and the aluminum body of the fan module can be seen, then replace electric auxiliary fan/shroud assembly with the new part - PN 64 54 6 921 395.**

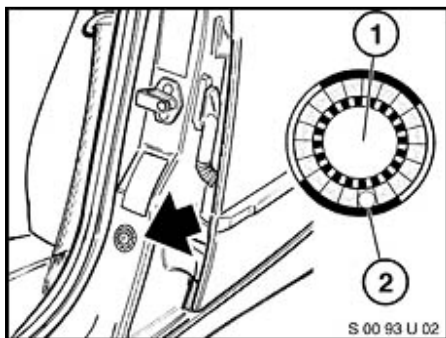
1. Check the Recall Campaign label affixed to the B-pillar:

**If the recall code number 316 is punched-out on the on the label (2), then NO further action is required.**

**If the number differs from 316, or recall label is not found, then continue with step 2.**

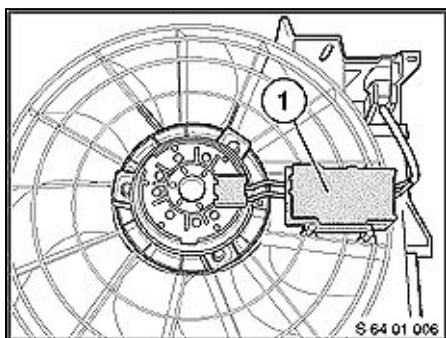
2. Check whether a fan with an external electronics box has been installed in the vehicle. The housing for the external electronics is installed on the fan shroud, between the fan and the engine block (1).

**If the electric fan with external electronics has been installed, then NO further action is required.**

**If the electric fan with internal electronics has been installed, then continue with step 3.**

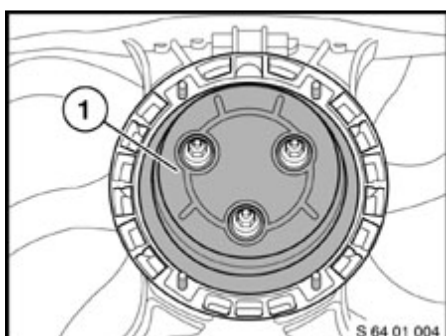
3. Remove electric fan/shroud assembly. For removal/installation instructions refer to TIS RA 17 11 031. Inspect the back of the fan housing:

**If the motor housing (1) is solid black, without cutouts (as shown on the illustration), then NO further action is required. Reinstall all previously removed components.**

**If the motor housing has cutouts and the aluminum body of the fan module can be seen, then replace electric auxiliary fan/shroud assembly with the new part - PN 17 11 7 510 617.**

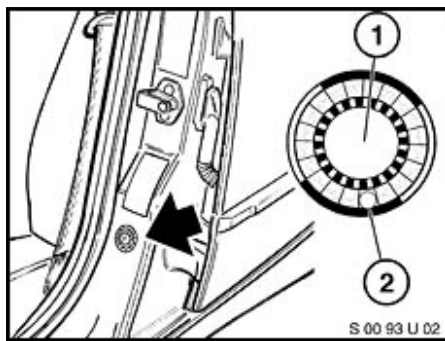
1. Check the Recall Campaign label affixed to the B-pillar:  
**If the recall code number 316 is punched-out on the on the label (2), then NO further action is required.**  
**If the number differs from 316, or recall label is not found, then continue with step 2.**

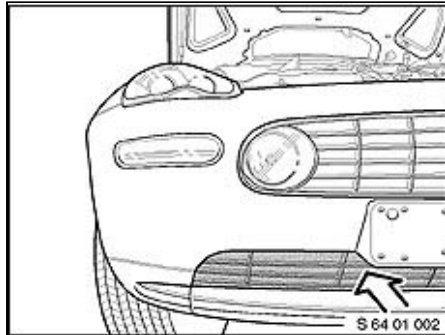
2. Check the BMW part number on the fan/shroud assembly. The part number is located on the lower right side of the shroud (molded next to the BMW logo, or on the label printed next to the logo). The number can be read from the outside, through the lower radiator grille (location indicated on the illustration).  
**UPDATE!** **If the part number is: 64 54 6 921 383 or 64 54 6 921 942, then NO further action is required.**  
**If the part number differs from that listed, then continue with step 3.**

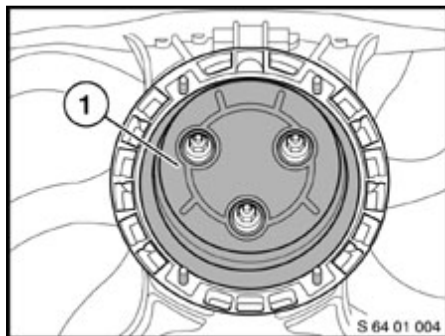
3. Remove top radiator cover and center air-guiding ducts.
4. Disconnect electrical connector to the auxiliary fan.
5. Remove electric auxiliary fan/shroud assembly, and inspect the back of the fan housing.  
**If the motor housing (1) is solid black, without cutouts (as shown on the illustration), then NO further action is required. Reinstall all previously removed components.**  
**UPDATE!** **If the motor housing has cutouts and the aluminum body of the fan module can be seen, then replace electric auxiliary fan/shroud assembly with the new part - PN 64 54 6 921 942.**

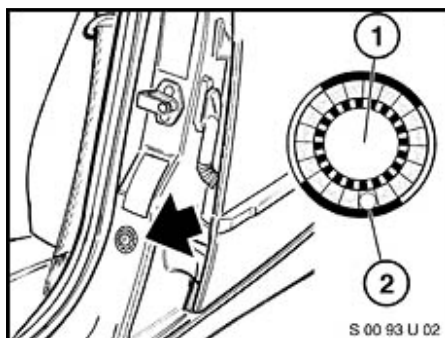
1. Check the Recall Campaign label affixed to the B-pillar:  
**If the recall code number 316 is punched-out on the on the label (2), then NO further action is required.**  
**If the number differs from 316, or recall label is not found, then continue with step 2.**

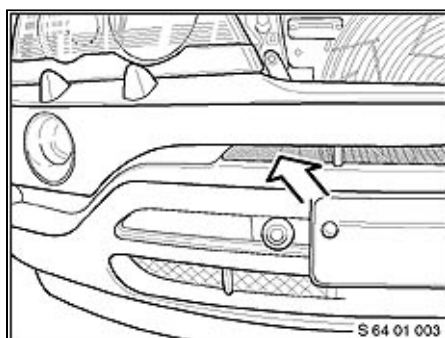
2. Check the BMW part number on the fan/shroud assembly. The part number is located on the lower right side of the shroud (molded next to the BMW logo, or on the label printed next to the logo). The number can be read from the outside, through the gap between bumper trim and the cover (location indicated on the illustration).  
**UPDATE!** **If the part number is: 64 54 6 921 381 or 64 54 6 921 940, then NO further action is required.**  
**If the part number differs from that listed, then continue with step 3.**

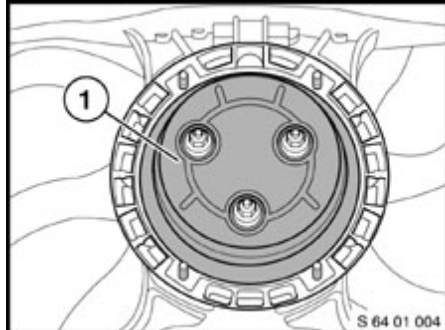
instructions refer to TIS RA 17 40 000. Inspect the back of the fan housing:

If the motor housing (1) is solid black, without cutouts (as shown on the illustration), then NO further action is required. Reinstall all previously removed components.

**UPDATE!** If the motor housing has cutouts and the aluminum body of the fan module can be seen, then replace electric auxiliary fan/shroud assembly with the new part - PN 64 54 6 921 940.

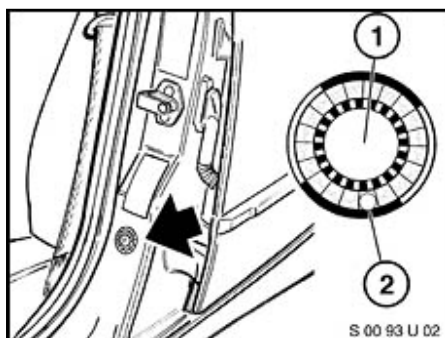
This Recall Campaign has been assigned code number **316**. After the vehicle has been checked, and corrected if necessary, obtain a label (SD 92-170) and:

- emboss your BMW dealer warranty number in the middle of the label (1);
- punch out code number **316** printed on the label and,
- affix the label to the **B** pillar as shown.
