STATIONARY VENTILATION WILL NOT ACTIVATE AFTER PARKING

E Series	Model Description	Production Date
G05	X5 Sports Activity Vehicle	To July 1 st 2019
G07	X7 Sports Activity Vehicle	To July 1 st 2019
G12	7 Series Sedan	To July 1 st 2019
G14	8 Series Convertible	To July 1 st 2019
G15	8 Series Coupe	To July 1 st 2019
G20	3 Series Sedan	To July 1 st 2019

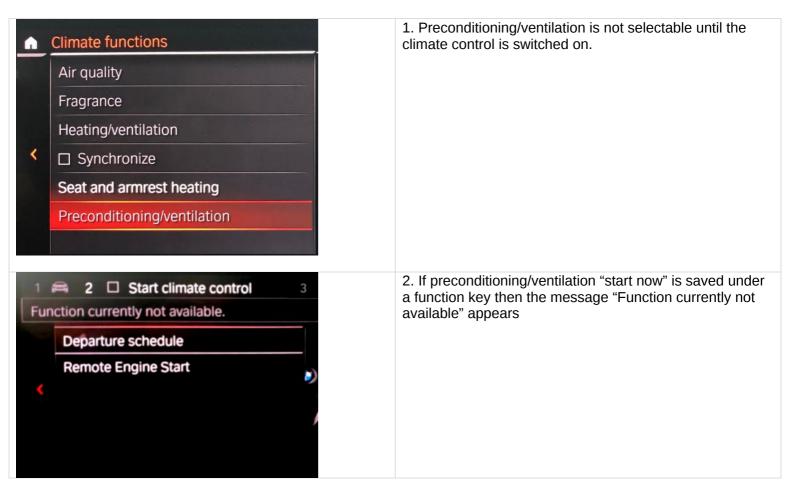
Scenarios:

Activation of stationary ventilation is not possible after parking the vehicle.

Software in the air condition control panel (IHKA).

Reprogram the vehicle.

- 1. Perform diagnosis with the latest version of ISTA, working through test module, if needed.
- 2. Program the vehicle using ISTA 4.18.3x or higher (released August 2019).
