## MODEL

G30 (5 Series Sedan)

Vehicles from Start of Production to July 1 2017 equipped with option codes:

- ZDT Drive Assistance Plus
- 5AT Camera

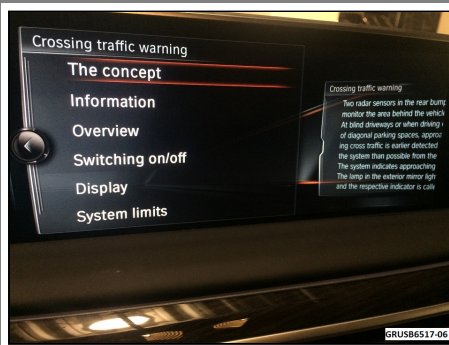
The crossing traffic warning (right of way warning) section is missing from the integral owner's manual (IBA). The picture below shows the missing text.

Software error in the Head unit IBA file

Reprogram and encode the vehicle with ISTA/P 3.62 or ISTA 4.06.01

Program the vehicle using ISTA/P 3.62.0 or ISTA 4.06.01 or higher (these versions are expected to release Mid-June 2017).
