112 (i8)	115 (i8 Roadster)		
----------	-------------------	--	--

The alarm (DWA) system of the vehicle is being triggered accidentally.

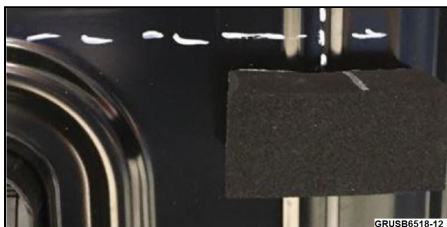
The tilt sensor is too sensitive. Activation can occur without touching the vehicle due to loud noises (vibrations) in the vicinity of the vehicle.

- Remove emergency power siren according to REP 65 75 055 - Install and remove/replace emergency power siren with tilt alarm sensor.
