**SERVICE ACTION: REWORK ROOF-MOUNTED AERIAL**

F90 M5	G12 7 Series	G30 5 Series
--------	--------------	--------------

This Service Action involves 5 Series, 7 Series and M5 vehicles produced from April 2018 through May 2018.

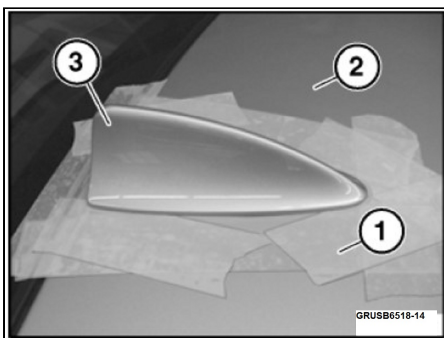
A gap in the roof-mounted aerial adhesive could cause water to leak into the vehicle interior.

During production the roof-mounted aerial was not sealed correctly.

Remove and reinstall the roof-mounted aerial housing, as described in **'REP 65 20 030 R&I roof-mounted aerial'** below.

- Clean the roof (2).
- Mask the roof (2) around the empty roof-mounted aerial housing (3) using yellow plastic adhesive tape (1). Slide the plastic adhesive slightly under the empty roof-mounted aerial housing (3).
- Cut the adhesive bead and remove the empty roof-mounted aerial housing (3).
