G05 (X5 Sports Activity Vehicle)	G12 (7 Series Sedan)	G15 (8 Series Coupe)	G30 (5 Series Sedan)
G32 (640i Gran Turismo)	I12 (i8 Coupe)

Vehicles produced from July 1, 2018 to November 5, 2018

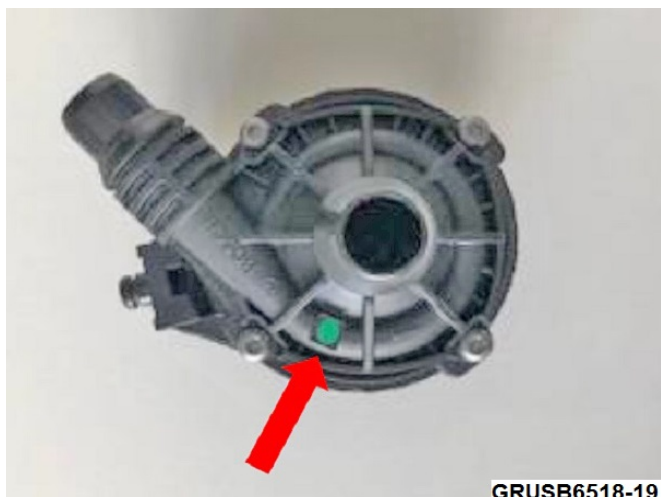
GRUSB6518-19

Electromagnetic interference caused by the electrically-powered auxiliary water coolant pump.

Note: When replacing the auxiliary coolant pump, ensure that it has a green dot (arrow) which indicates a revised component.

Replace the auxiliary coolant pump.

3. Follow Repair Instructions REP 64 11 262 "Removing and installing/replacing the coolant pump".
4. After installation of the new auxiliary coolant pump, bleed the cooling system.
 - For all models except I12: Follow SI B17 01 10 "Proper evacuation and/or filling of cooling system after repairs"
 - For I12 only: Follow SI B17 02 18 "Proper coolant bleeding procedure"
5. Verify the absence of radio static interference on the FM band after moving the vehicle outdoors.
