WHIRRING NOISE IN VEHICLE HEARD BETWEEN THE SUBWOOFERS WHEN LOUD MUSIC PLAYING

E-Series	Model Description	Production Date
I15	i8 Roadster	From 3/1/2017 to End of Production

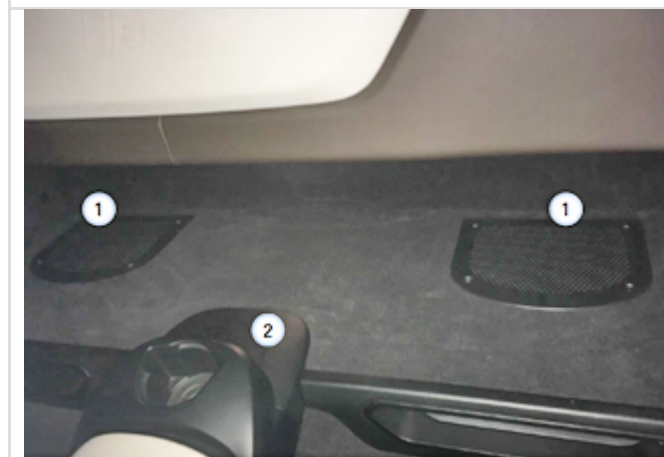
To access the harness:

- Remove both subwoofer speaker grilles (1)
- Remove the center console trim behind the cupholder (2)

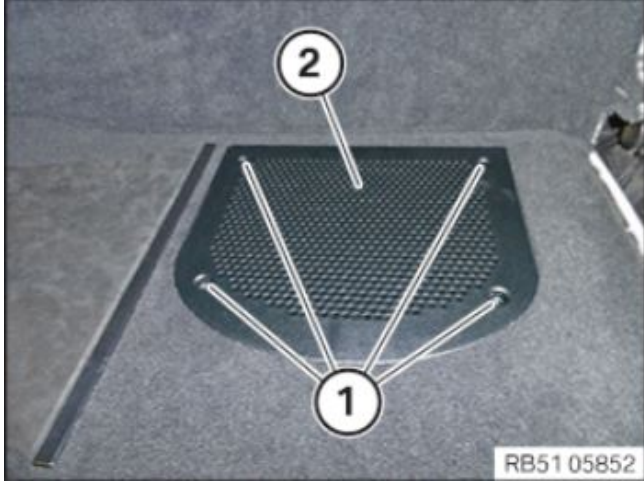
Remove the speaker grill at the 4 retaining screws (1), then lift the grill (2).

Upon reinstallation, the screws must be torqued to 1.8 Nm.

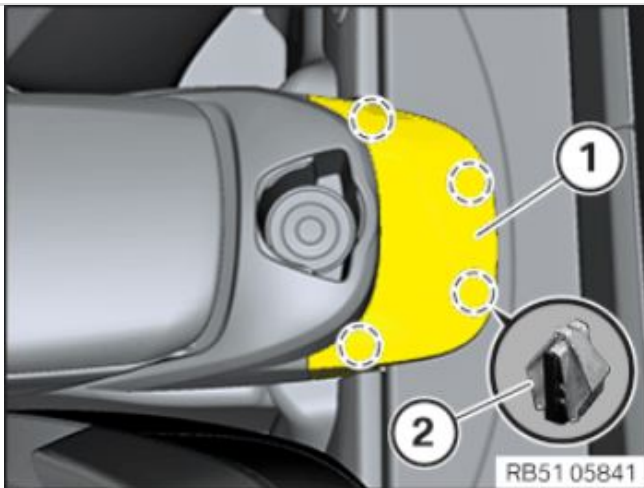
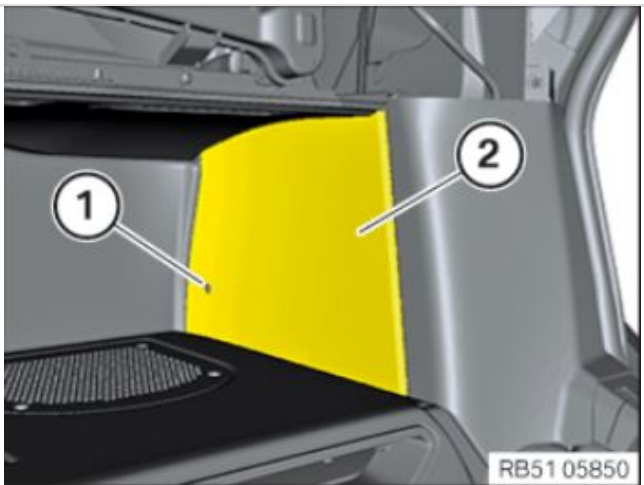
When removing the center console trim (1) behind the cupholder, there are four retaining clips (2).

To remove the left and right side trim panels (2) you must first remove the expanding rivet (1).

Disengage the trim panel (2) by pushing forward, rotate it down and inward to remove.

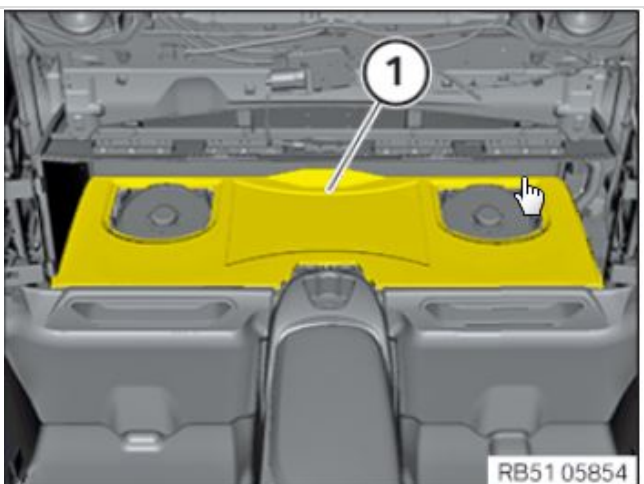
Lift up the removable panel (storage shelf; 1).

- Remove the wiring harness from its retainer clips (5)
