MODEL

E-Series	Model Description	Affected Option Code
F90	M5 Sedan	6U3 BMW Live Cockpit Professional In conjunction with: 6FH Rear Seat Entertainment Professional Or 6FR Rear Seat Entertainment Professional
G05	X5 Sports Activity Vehicle	
G06	X6 Sports Activity Coupe	
G07	X7 Sports Activity Vehicle	
G12	7 Series Sedan	
G32	6 Series Gran Turismo

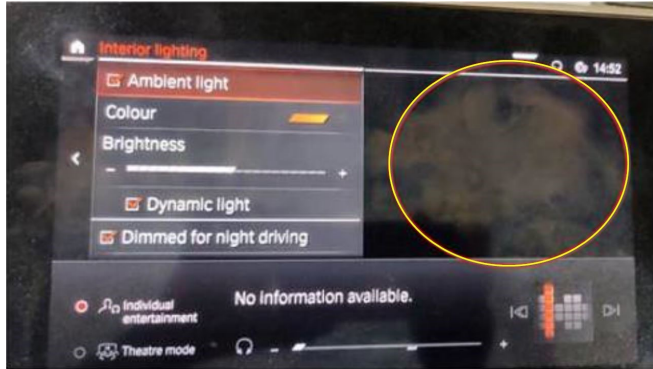
The rear seat entertainment screens do not display any preview images at times.

Software in the Head Unit High (HU-H3).

Program the vehicle.
