What's New:

- Models added
- How to proceed if the Over-the-Air (OTA) update fails

Customers may be receiving onscreen messages concerning updates of their navigation system.

Database mapping procedure in vehicles with the NBT EVO Head Unit (Head Unit high 2) has been changed to automatic, periodic, Over-the-Air (OTA), regional, incremental updates.

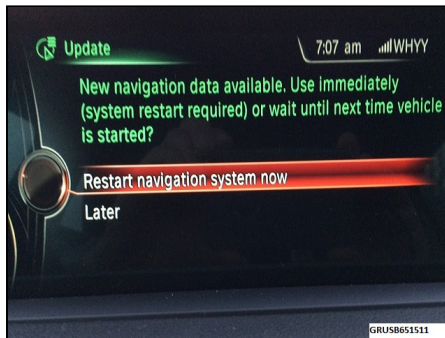
- OTA automatic download to vehicle may take 40 minutes. Download may take multiple drive cycles to complete. Customer receives no visual indication of OTA download process.
- When the OTA download is complete, a percentage (%) display will appear at the top right of the screen. This % will gradually increase to 100% as the downloaded map data is installed into the head unit. Once the head unit update has reached 100%, the customer will receive a message in the display screen as shown below:

- 'Restart navigation system now'- system will immediately reboot, interrupting active navigation. When system comes back online, customer will be given option to resume guidance to their destination.
- 'Later' (Recommended) - software update will complete the next time the vehicle is restarted. Current navigation will continue.

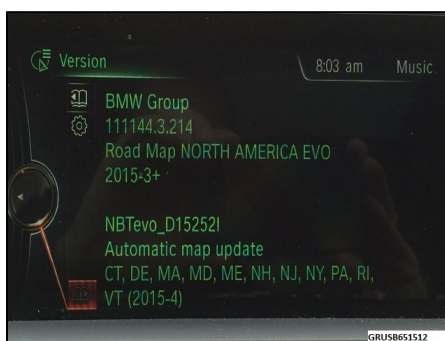
- 100% Completion messages ("Later"/"Restart...") may not be able to be verified via the Check Control (CC) test plan in ISTA. This message may not set in memory as a standard Check Control message.
- List of installed software accessible via the OPTION button on the I-drive controller. Prior to any incremental updates, only Road Map North America version is listed. After the incremental update, additional software will be listed under automatic map update as seen below.

The example above is for a vehicle only driven in North East US states. Only that part of the North American road map was automatically updated OTA for this vehicle. Your geographic update area may vary based on driving history.
