RECALL 21V-096: REARVIEW CAMERA

This Service Information bulletin (Revision 3) replaces SI B66 02 21 **dated March 2021**

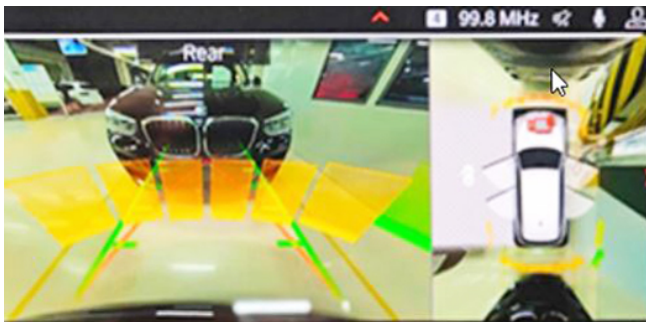
**Picture 1.**

The images are displayed in the **correct image position** on the CID for vehicles equipped with option code 6U3.

1. Visually check and compare the camera image in the display to pictures 1 and 2 above in the situation.
2. If the camera image displayed in the CID match picture 1, then no further repairs are required.
3. If the camera image displayed in the CID match picture 2, then complete the steps listed below.

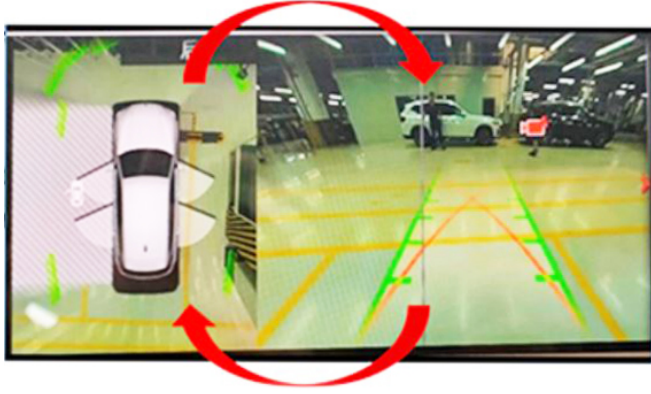
Picture 2.

Shows a possible failure in vehicles equipped with option 6U3.

The top view and rearview images are **incorrectly displayed** in the wrong position (swapped) on the CID.

Note: The camera icon is in the correct location, however it seems out of place due to wrong image location.

Software coding error in the ICAM control unit with Integration Level-

Encode the ICAM using ISTA 4.27.1x or higher (released December 2020).

4. Connect the vehicle to ISTA 4.27.1x or higher.
5. Start a new programming session, go to Advanced Tab.
6. Select **all** control units for encoding.
7. Calculate and accept measures plan.
8. Once the encoding/programming is completed, follow the rework list.
9. Depending on the rework list, if necessary, perform vehicle test and delete the error memory (faults).
10. Allow the vehicle to sleep for 5 minutes.
11. Reassess the vehicle.
Note: Camera image in the CID must match the picture 1 seen in the situation above.
12. If the image does not match picture 1, then recode the ICAM by repeating steps 5 – 9 above.

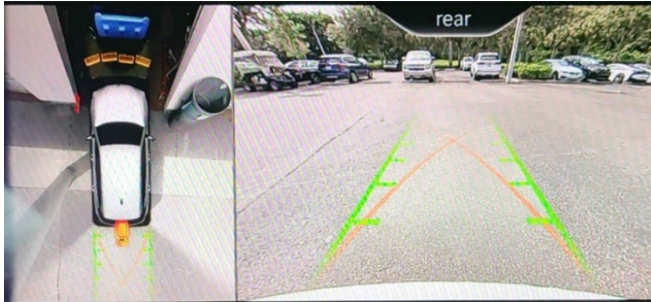
Picture 3.

Shows the **correct image display** for vehicles without option code 6U3.

Note: The correct image layout for vehicles without option code 6U3 is opposite to the layout for vehicles with option code 6U3 (seen in Picture 1 above).

1. Select reverse gear and check that the camera image is displayed in the CID.
2. If the camera image is displayed in the CID (reference picture 3 in Situation above), no further repairs are required.
