DRIVER ASSISTANCE REDUCED CCM DISPLAYED OR BLINDSPOT WARNING INOP

E-Series	Model Description	Production Date	Affected Option Code
F95	X5 M Sports Activity Vehicle (SAV)	Start of Production (SoP)	5AU – Active Driving Assistant Pro
F96	X6 M Sports Activity Coupe (SAC)		
G05	X5 SAV		
G06	X6 SAC		
G07	X7 SAV

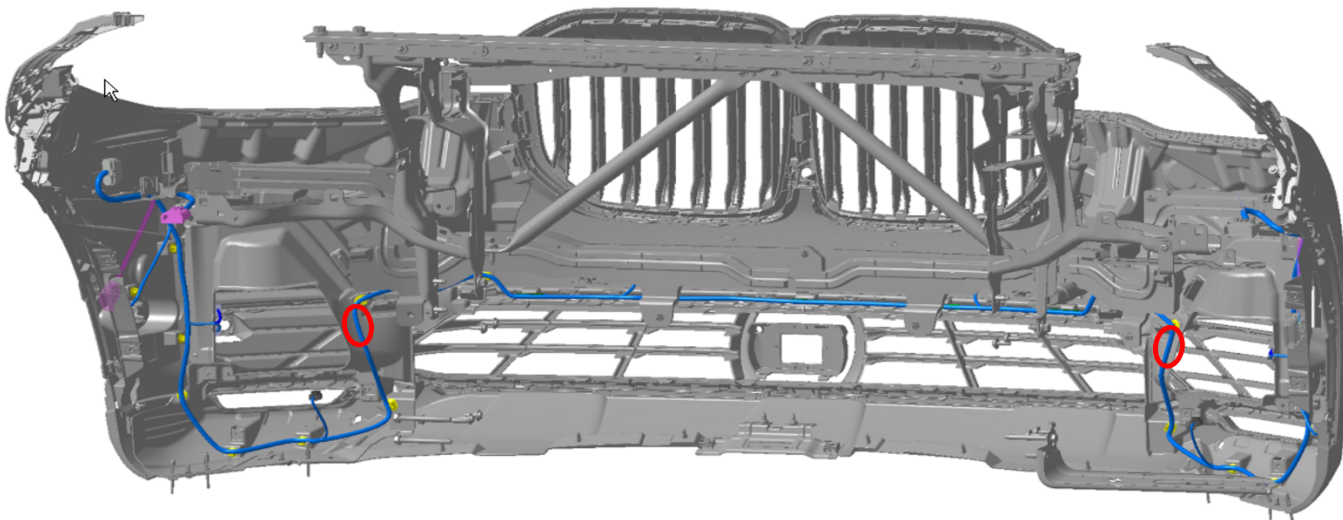
SRR wiring harness is pinched between bumper and bumper support. The small break in the harness insulation allows an electrical short-circuit.

4. Carefully inspect the front bumper wiring harness. See example photo above with locations. You may need to unwrap the harness for inspection. Is damage found in the above locations?

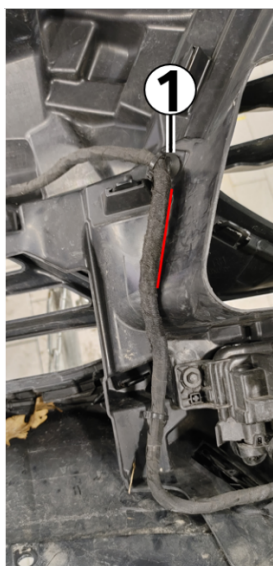
#1 - Support Clip

The location is approx. 30 mm from the support clip show in the example photo.

Install the piping in the area indicated by the red line.

6. Install wiring harness into 70 mm length of corrugated tubing.

Use abrasion resistant tape to secure both ends of the tubing to the harness and install the wiring back into proper position.
