MODEL

G30 (5 Series Sedan)

SITUATION

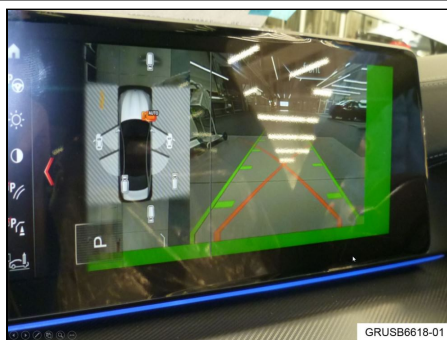
Wide green bar across bottom and up right side of Central Information Display (CID) when reverse gear is selected and the Surround View camera is active.

Software error in Surround View Camera control unit (iCAM2)

I-level S15A-17-11-520 to S15A-17-11-540

Reprogram vehicle with ISTA 4.09.3x (I-level S15A-17-11-541) or a more recent version.
