RECALL 20V- 598: ENCODE CONTROL UNITS (REARVIEW CAMERA)

This Service Information Bulletin (Revision 4) replaces SI B66 14 20 **dated September 2020**.

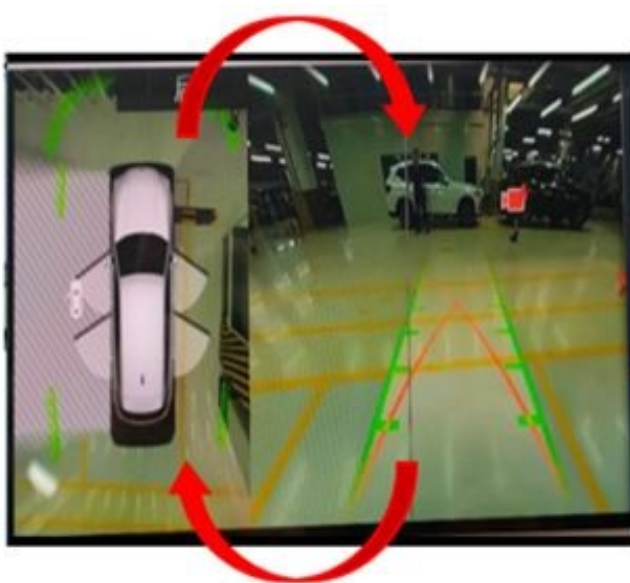
This picture shows a possible failure in vehicles equipped with option 6U3 (Live Cockpit Pro - incl. Navi).

The top view and rearview images are **incorrectly displayed** in the wrong position (swapped) on the CID.

Software coding error in the ICAM control unit.

Encode the ICAM control unit with ISTA 4.25.4x (released October 8, 2020) or higher.

1. Visually check and compare the camera image in the display to pictures 1 and 2 above in the situation.
2. If the camera image displayed in the CID matches picture 1, then skip step 3 and proceed from step 4.
3. If the camera image displayed in the CID matches picture 2, then no further action is required.
4. Connect the vehicle to ISTA.
5. Start a new programming session, go to Advanced Tab.
6. Select **all** control units for encoding.
7. Calculate and accept measures plan.
8. Once the encoding/programming is completed, allow the vehicle to sleep for 5 minutes.
9. Reassess the vehicle.

10. If the image does not match picture 2, then recode the ICAM by repeating steps 5 – 9 above.

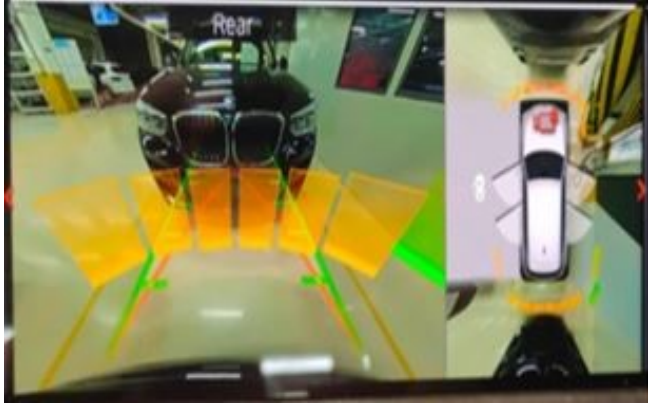
Here the images are displayed in the **correct image position** on the CID for vehicles equipped with option code 6U3 (Live Cockpit Pro - incl. Navi).

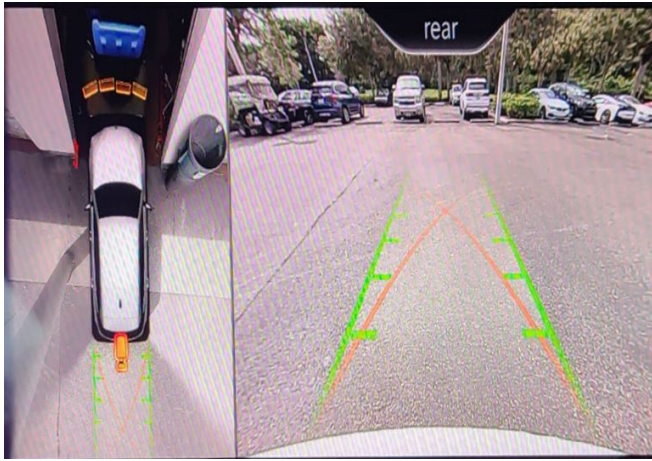
This picture shows the **correct image position** for vehicles without option code 6U3.

1. No visual inspection required; however, the ICAM control unit in these vehicles must be encoded.
2. Connect the vehicle to ISTA and start a new programming session.
3. Then go to “Advanced Tab”.
4. Select **all** control units for encoding.
5. Calculate and accept measures plan.
6. ISTA will prompt to encode the ICAM control unit at least 2 more times.
