PARKING ASSISTANCE SYSTEM FAILED

SIB 66 16 20 2020-11-19

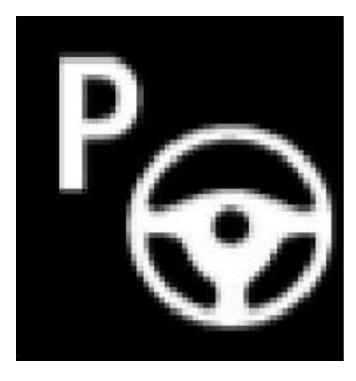
CCM ID 451 - Park Assist Assume vehicle control. Park Assist failed. Parking maneuver was interrupted. If this occurs repeatedly, have it checked by the Service Center.

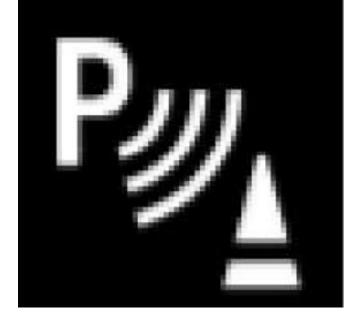
The following two CCM utilize the same icon:

CCM ID 918 – Parking Assistance failure Parking Assistance failure, park yourself*. Have it checked by your Service Center.

CCM ID 977 - Lateral Parking Aid Lateral Parking Aid failure, park autonomously. Drive to your Service Center at your convenience.
